**MINUTES
PARK BOARD
REGULAR MEETING
MONDAY, APRIL 26TH, 2021
5:30 P.M.**

TECHNICAL MEMORANDUM
WHITAKER PARK SWIMMING POOL
LIMITED STUDY
Pryor, Oklahoma

SWIMMING POOL REPAIRS

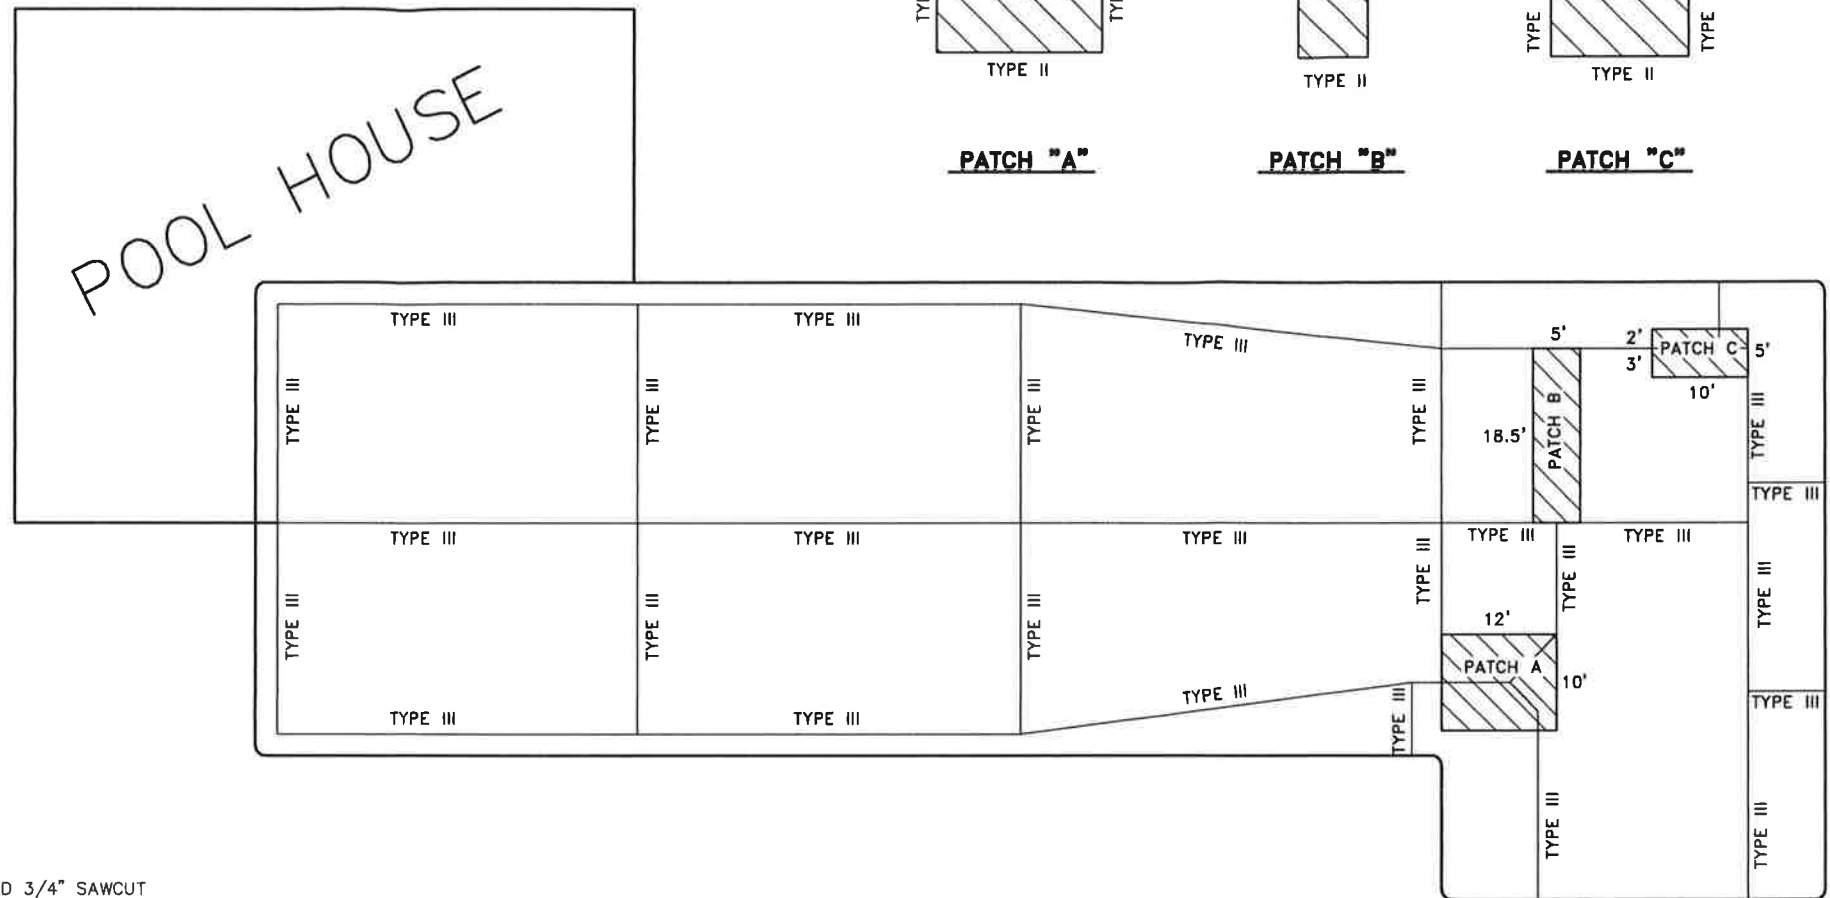
JOINT AND CONCRETE REPAIR LAYOUT
SCALE: 1"=10'

In addition, specific sections of the concrete floor have experienced more extensive damage to just seal the joints. We have isolated three sections of concrete slab that must be saw cut removed and replaced including sub grade use of flowable fill and drilled dowels to surrounding concrete flooring. The three sections occur primarily in the deep end of the pool where subterranean water migration has collected and during the very cold winter months have caused extensive movement due to freeze expansion. Water proofing the pool bottom mitigating subterranean water movement or improved collection of that water is needed to minimize such slab damage in the future.

LENGTH OF JOINTS:	740 L.F.
AREA OF REPAIRS:	
AREA A	120 SF
AREA B	90.5 SF
AREA C	50 SF
TOTAL AREA	260.5 SF

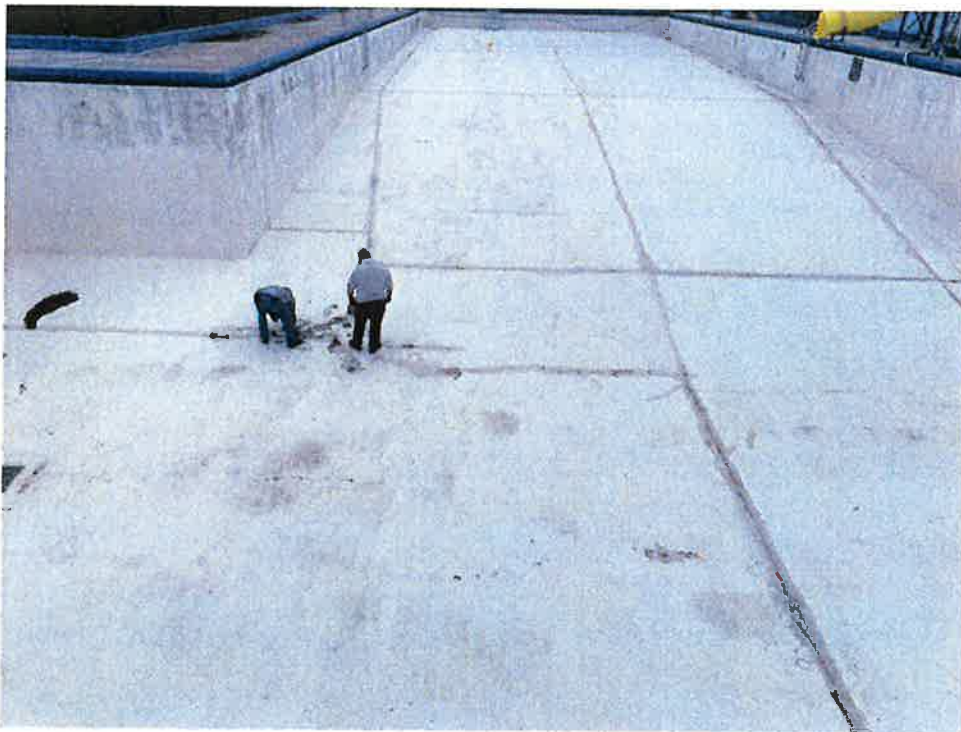
Figure 2 TEAM EXPLORING SPAULING JOINT

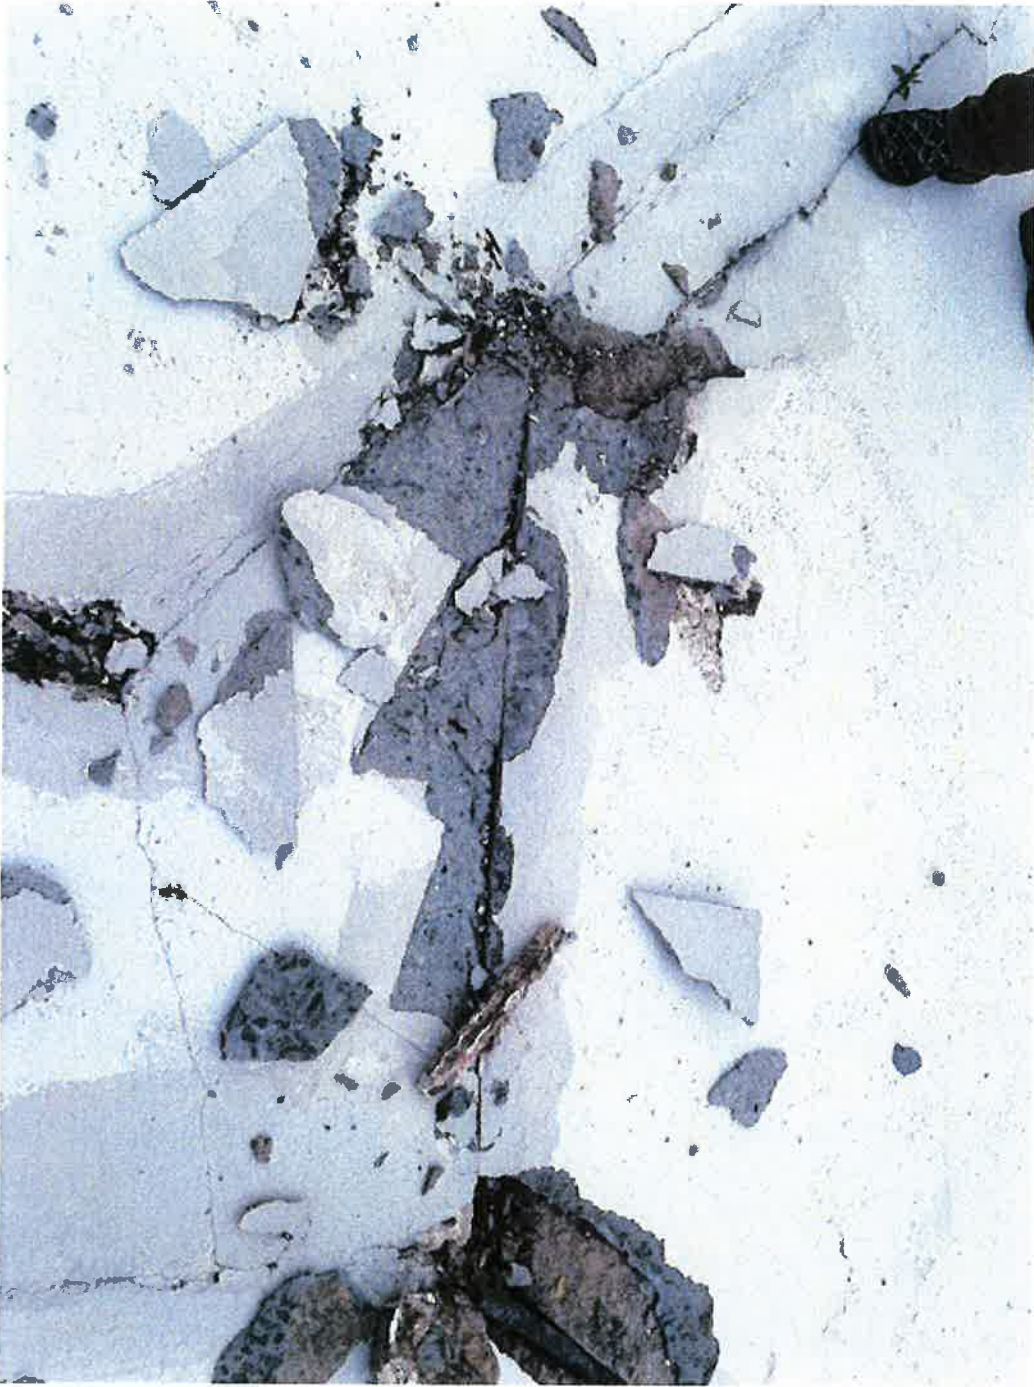
Figure 3 CLOSE UP OF WEATHERED JOINT

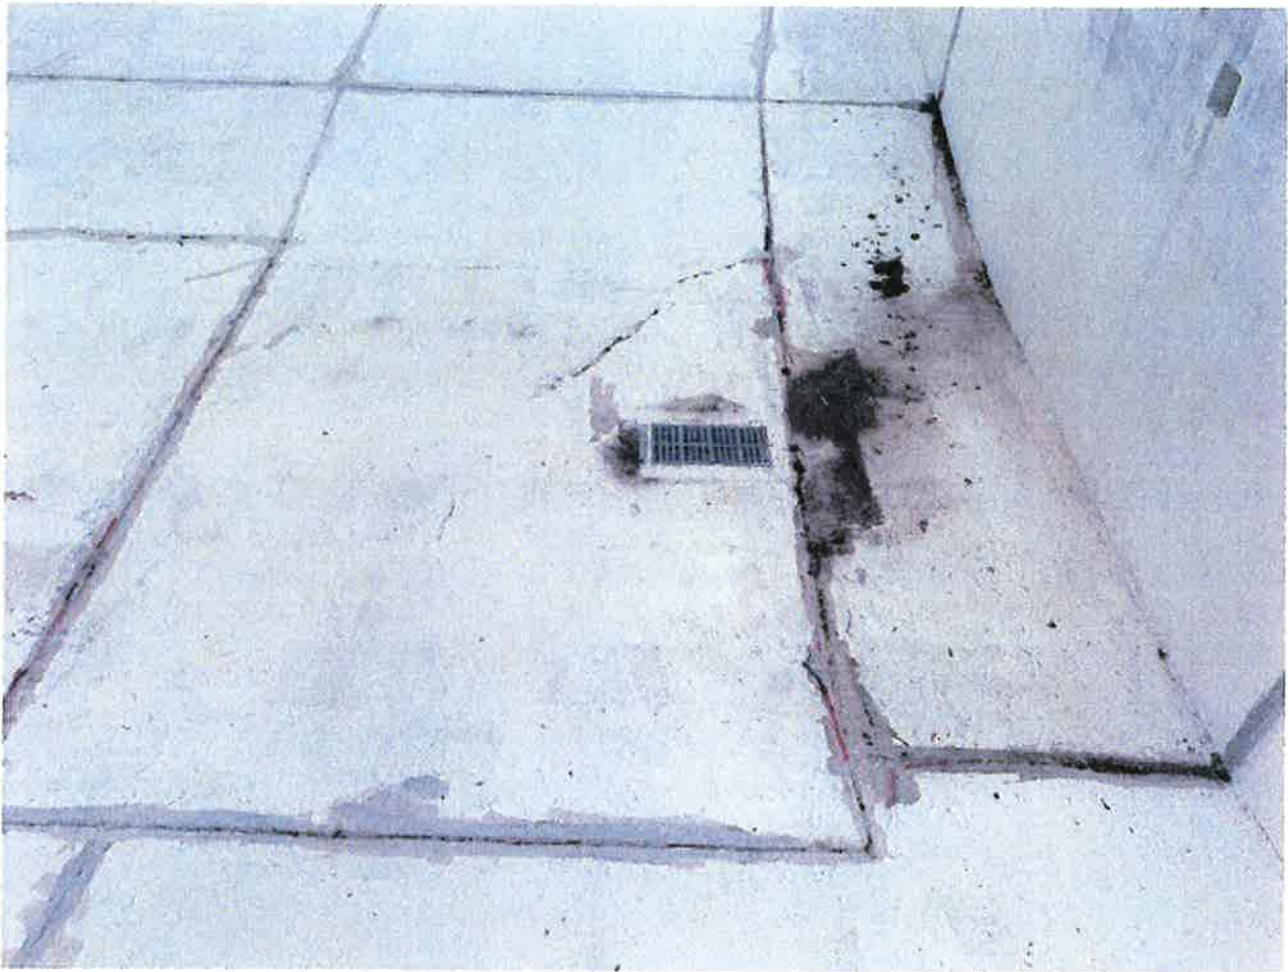
Figure 4 CONCRETE STRUCTURAL CRACK

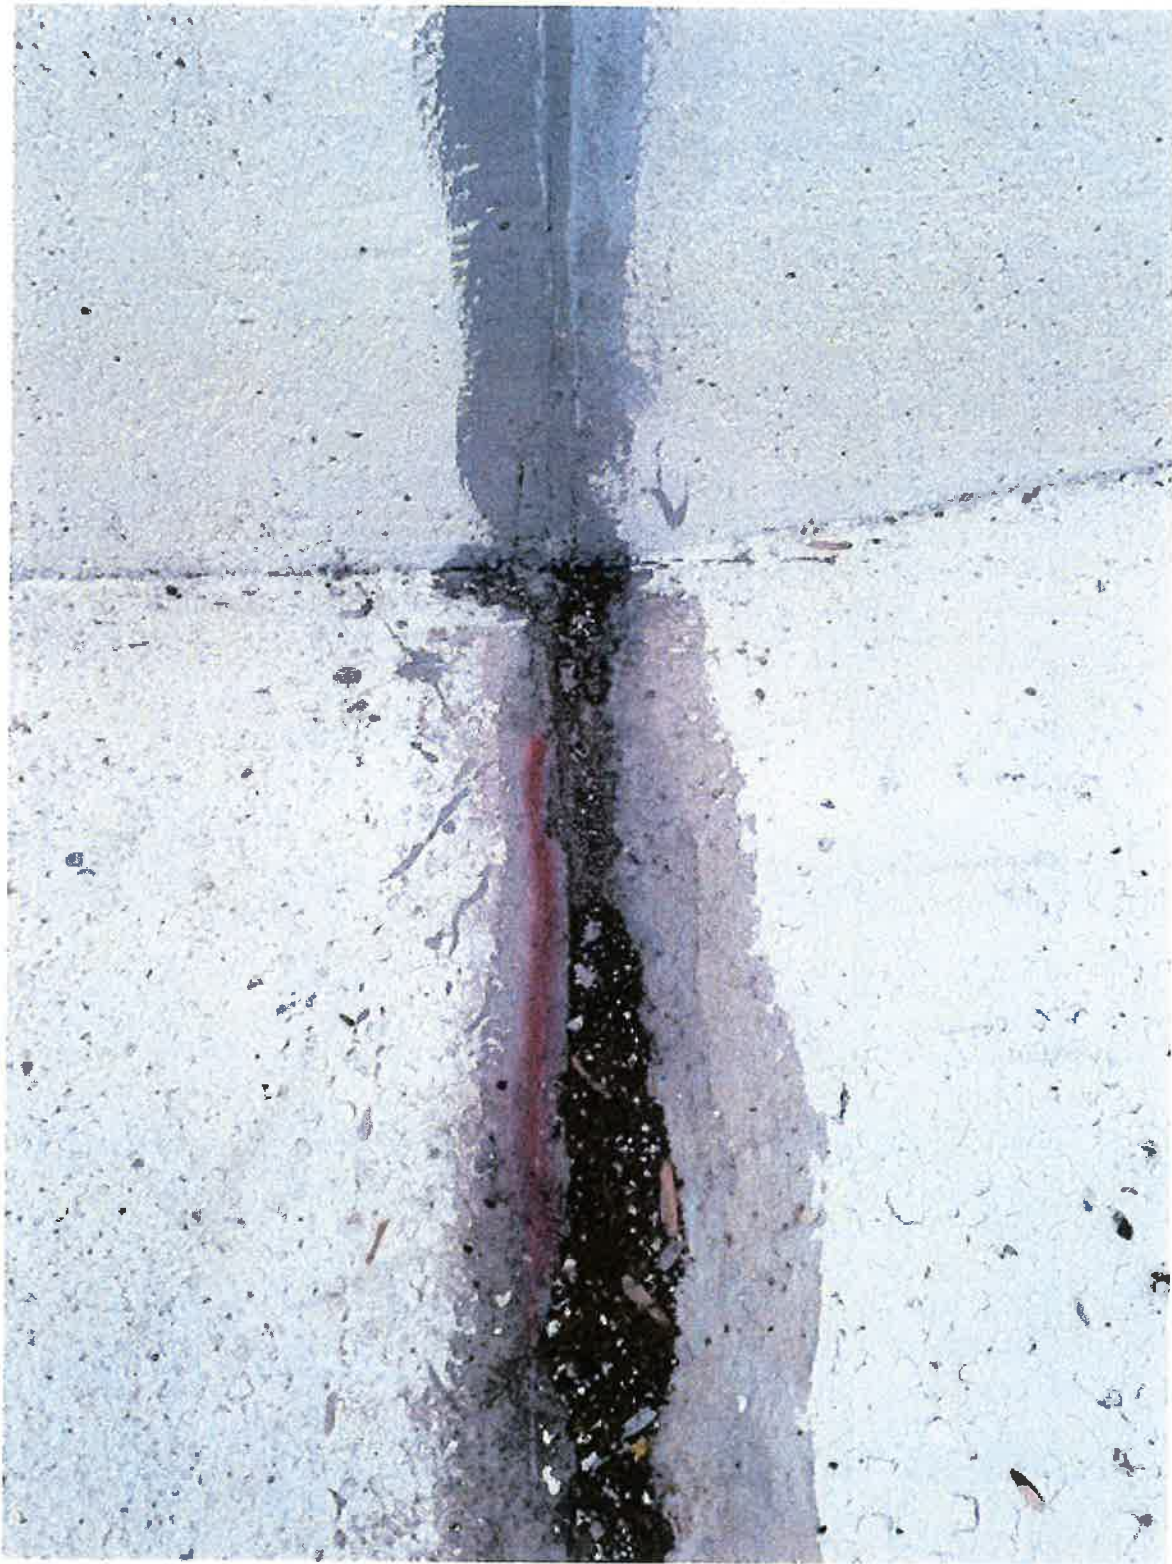
Figure 5 LEAKING BRITTLE CONST. JOINT

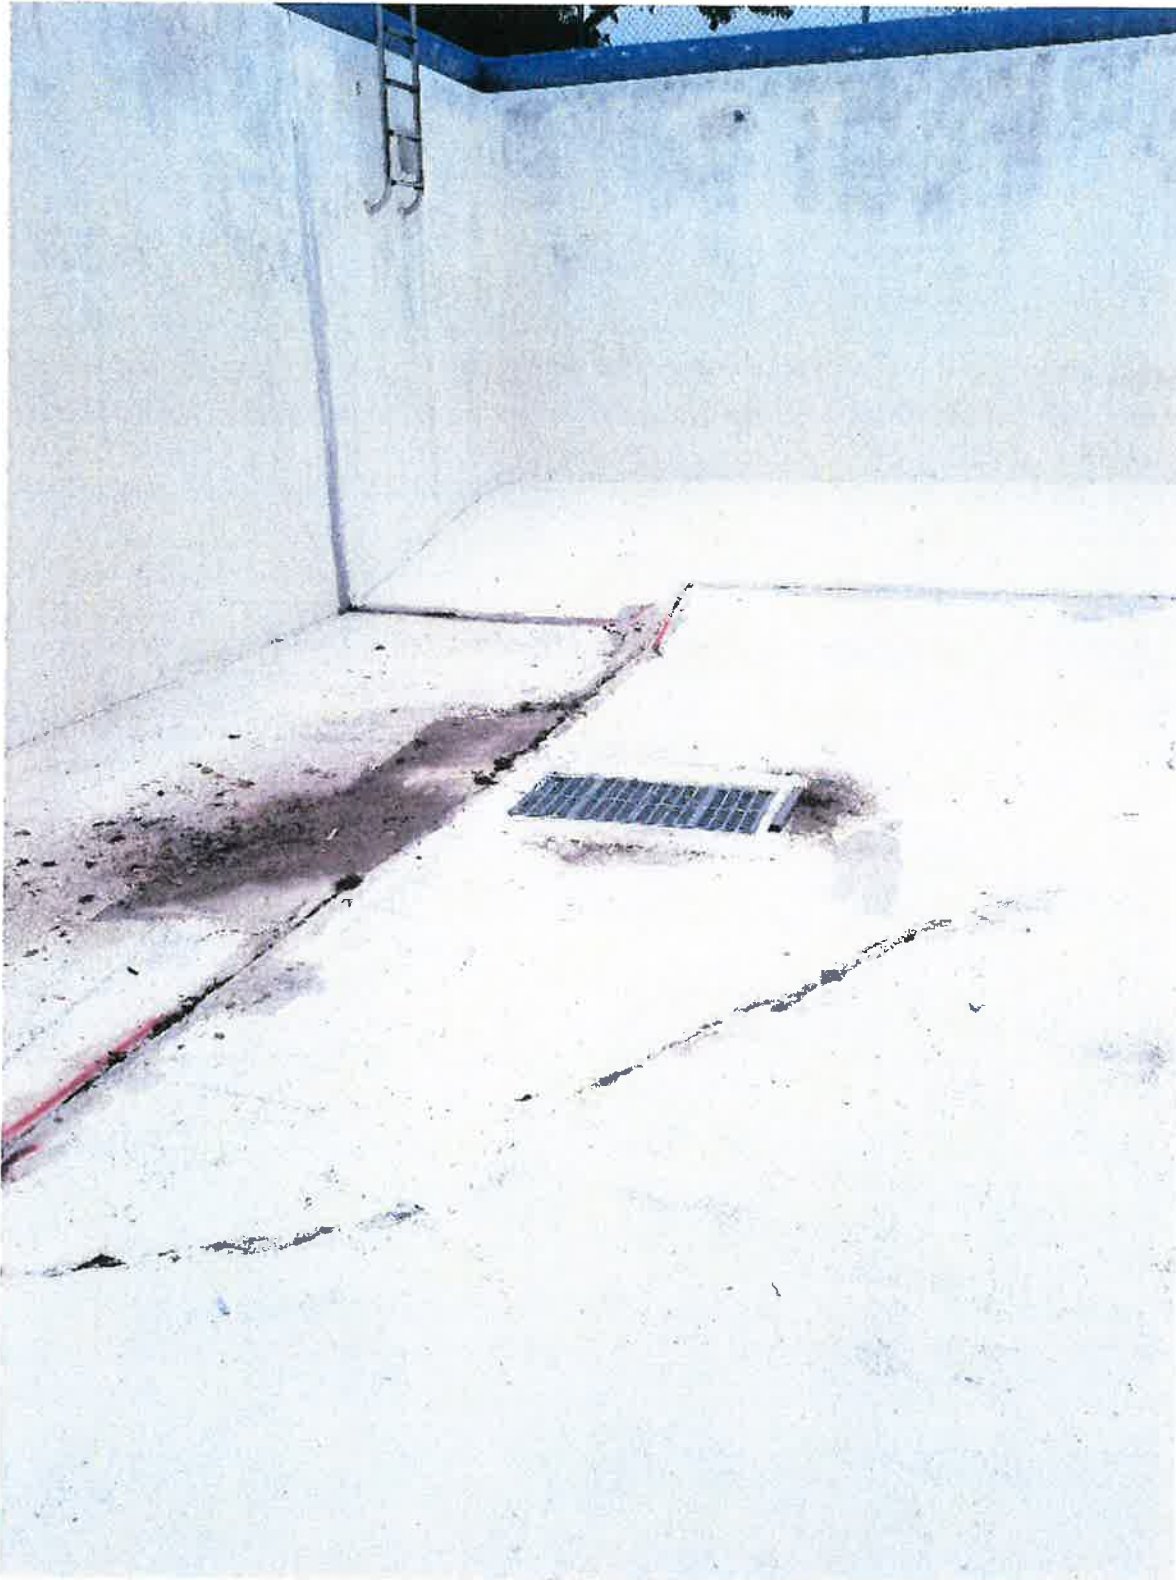
Figure 6 DEEP END POOL WATER LEAKAGE

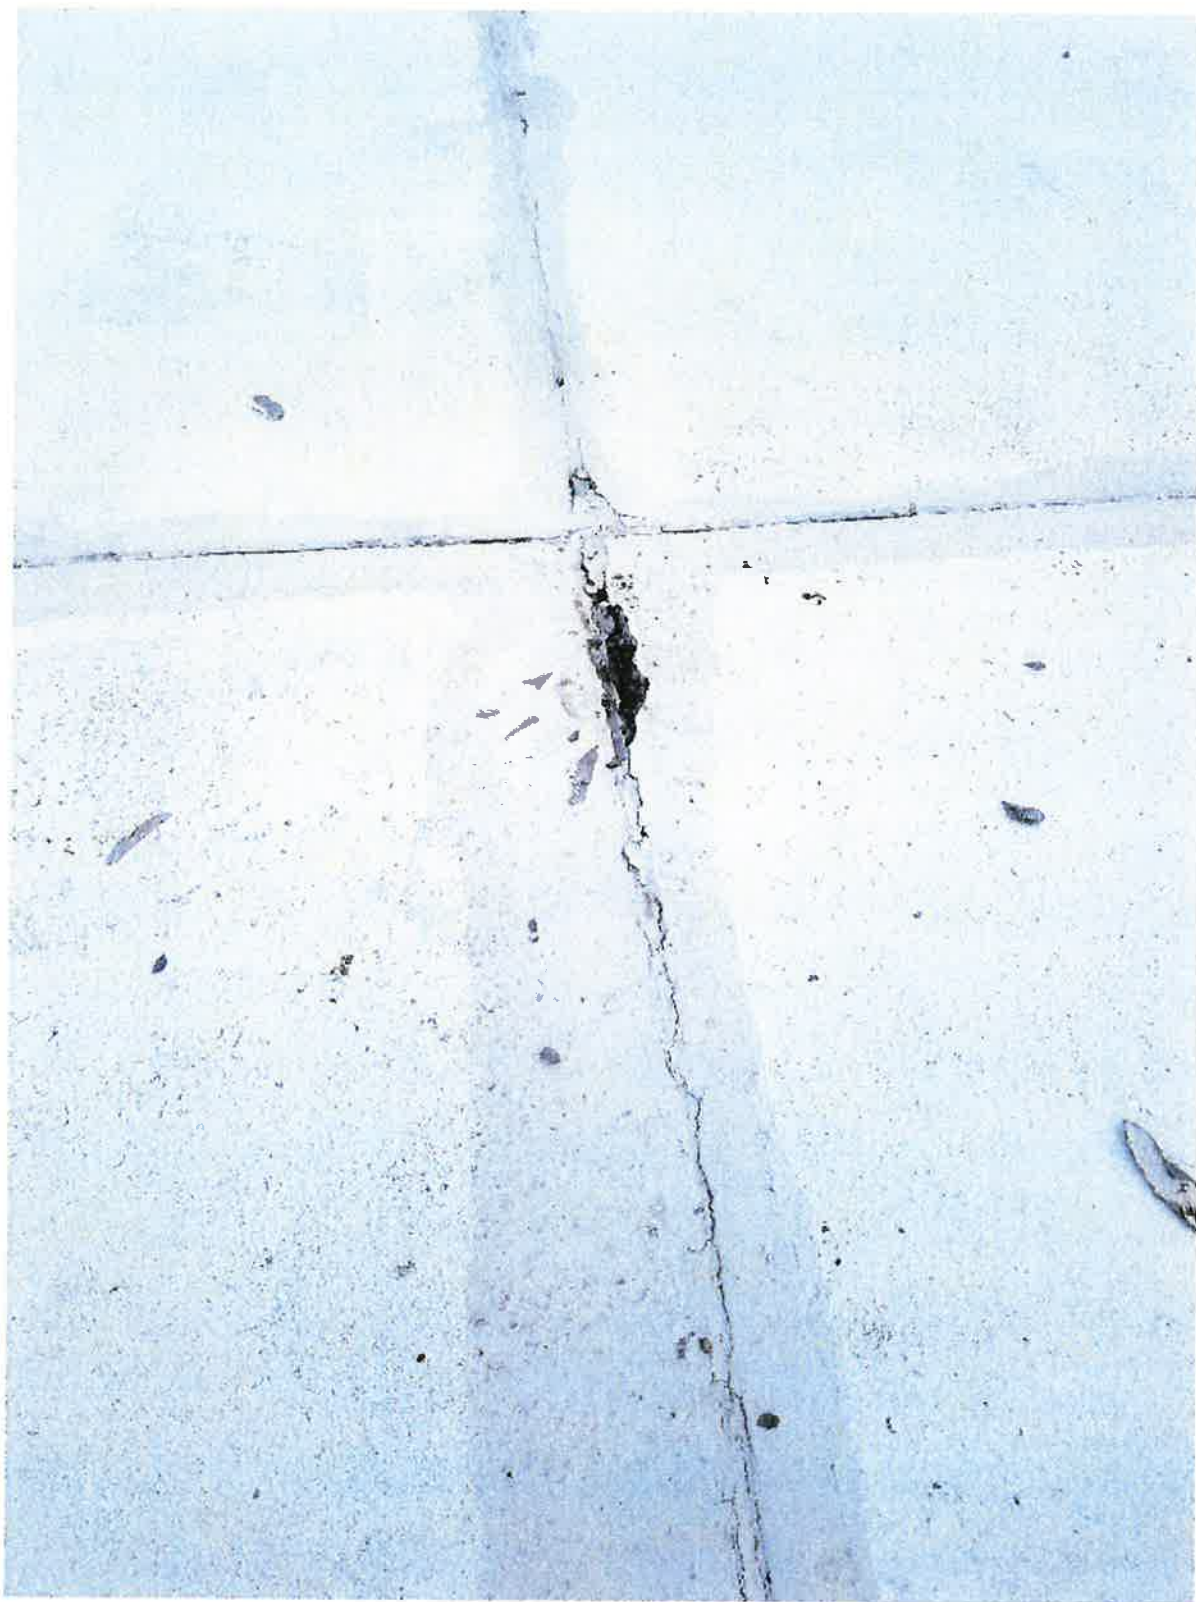
Figure 7 JOINT WITH DETACHED CONCRETE SEAM

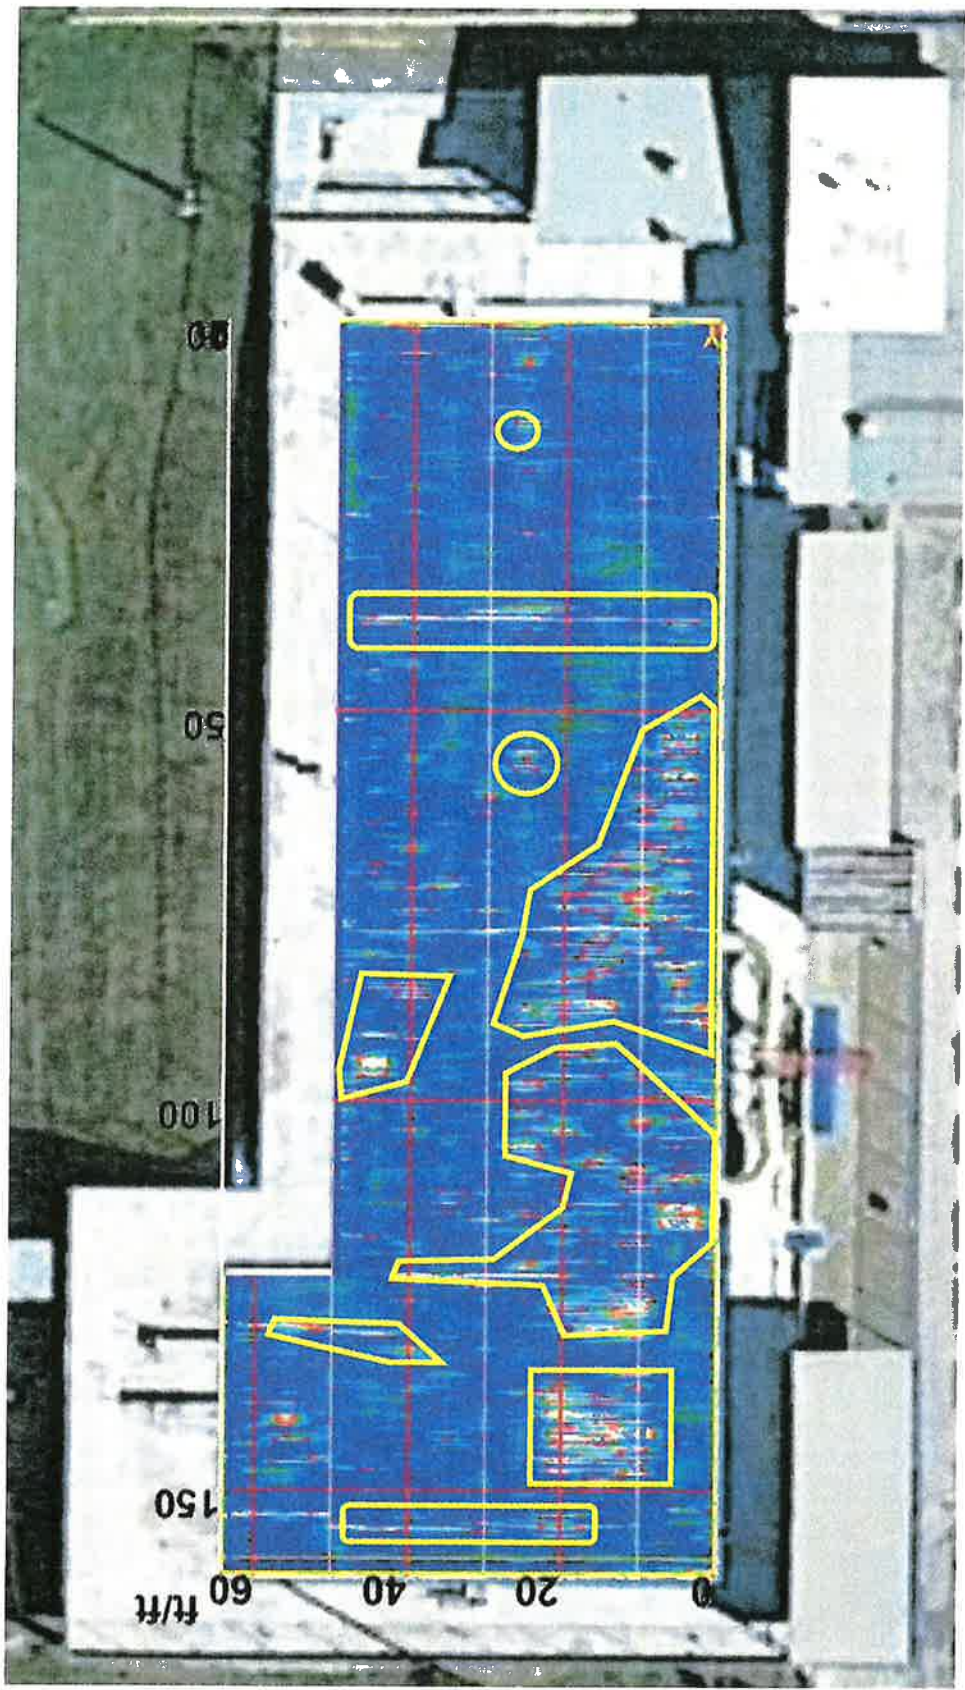
GPR Results Diagram	Exhibit
Public Swimming Pool	2
Pryor, Oklahoma

Areas circled in yellow are potential voids under the slab. The GPR cannot quantitatively measure the vertical airspace in a void but based on prior experience we estimate the voids likely range from 1/2 inch to 3 inches of vertical expression.
