**INSPECTION REPORT  
FOR THE EXISTING  
OUTDOOR MUNICIPAL  
SWIMMING POOL  
IN  
Pryor, Oklahoma**

**November, 2019**

**PADDOCK ENTERPRISES, INC.  
4201 N. MERIDIAN - P.O. BOX 12693  
OKLAHOMA CITY, OKLAHOMA 73157**

TECHNICAL MEMORANDUM  
WHITAKER PARK SWIMMING POOL  
LIMITED STUDY  
Pryor, Oklahoma

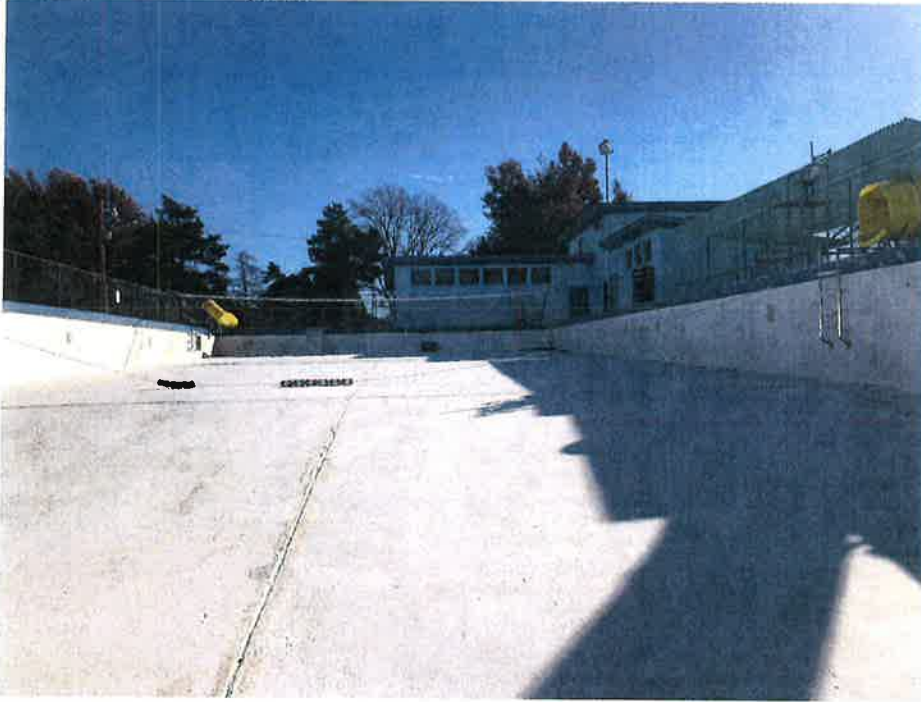
Water comes up through the expansion joints and cracks in the pool floor during the winter months when water is below the pool.

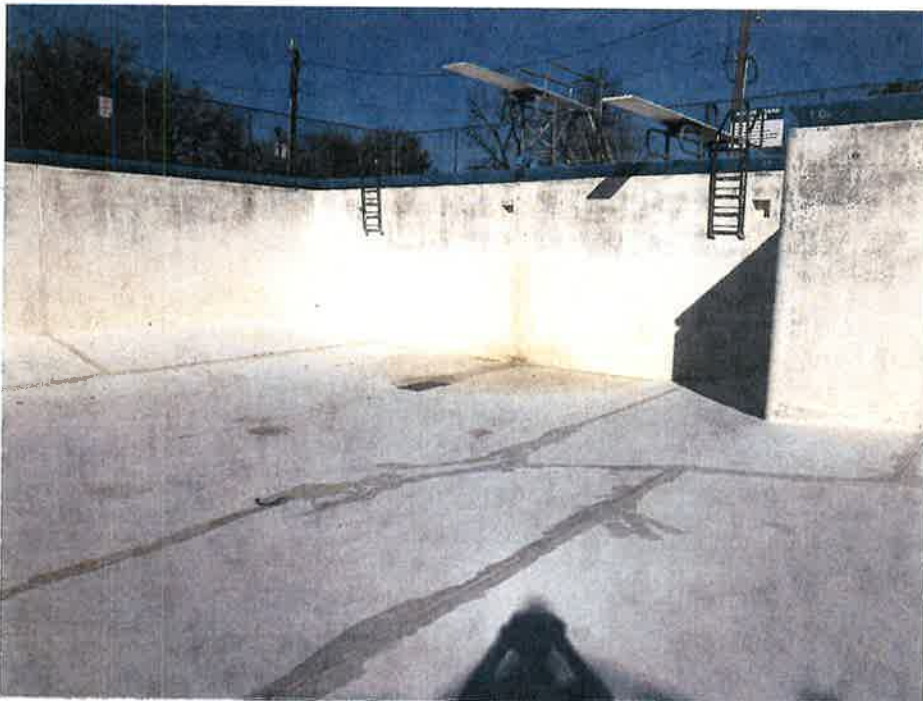
Expansion Joints: The pool is a sectional poured structure. The expansion joints are failing in areas.

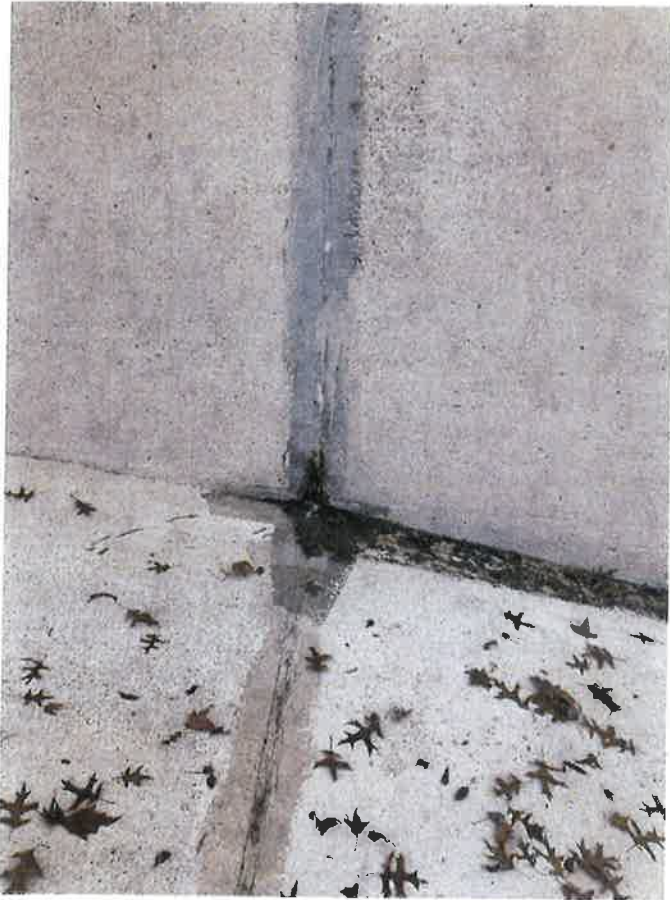
Cracks in deep end floor.

Standard note on crack repairs: It is not recommended to cut out crack and create a caulk joint. This usually increases maintenance and repairs to this joint. Sandblast and expose crack, then inspect prior to determining method of repair.

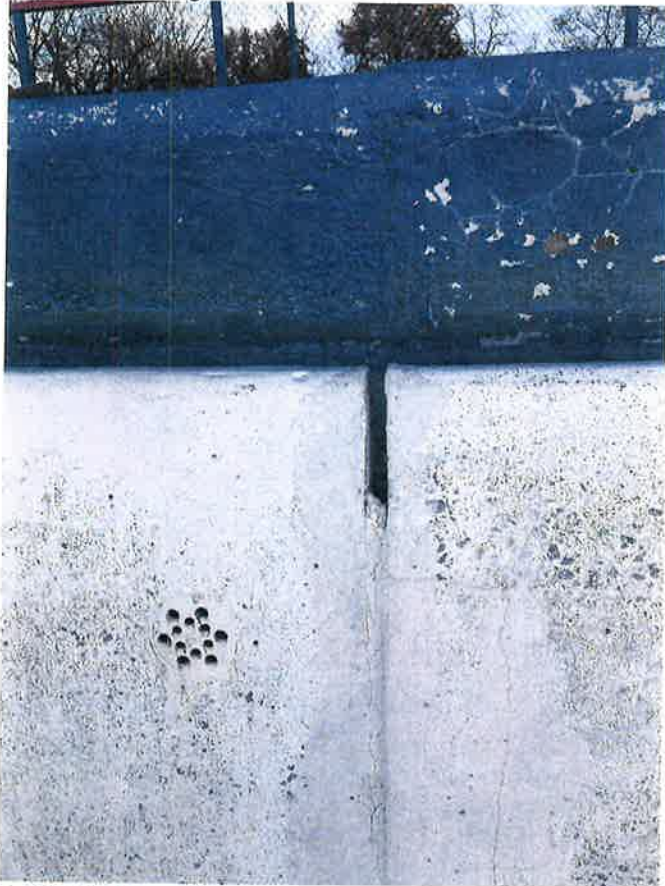
Structural: There are numerous cracks in the walls and floor of the pool. At the time of our inspection there was at least one wall crack that was leaching water, see photo.

Crack leaching water.

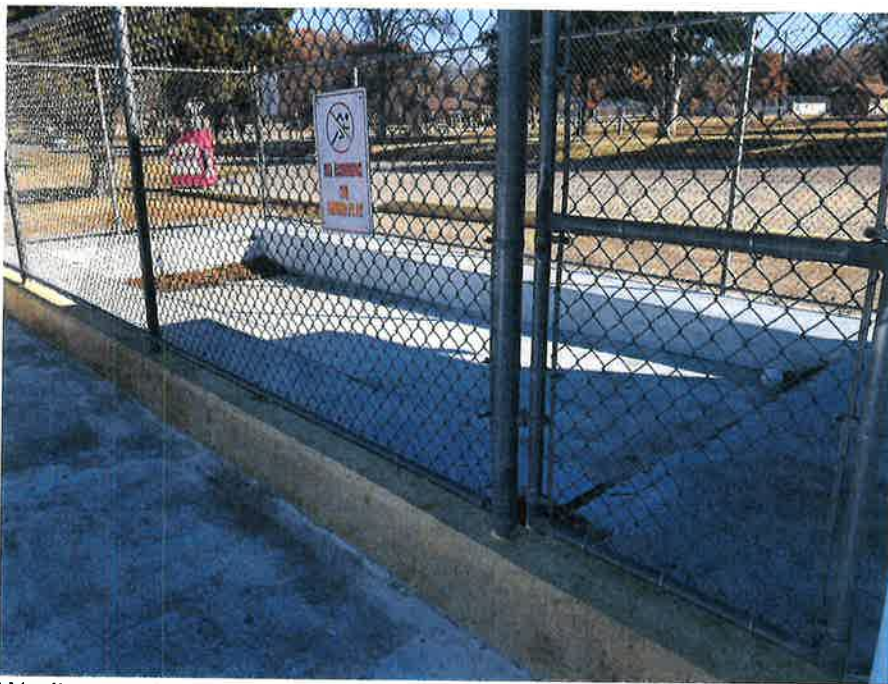
Overflow: Expansion joint open in gutter overflow should be caulked to aid in gutter operation.

Perimeter overflow.

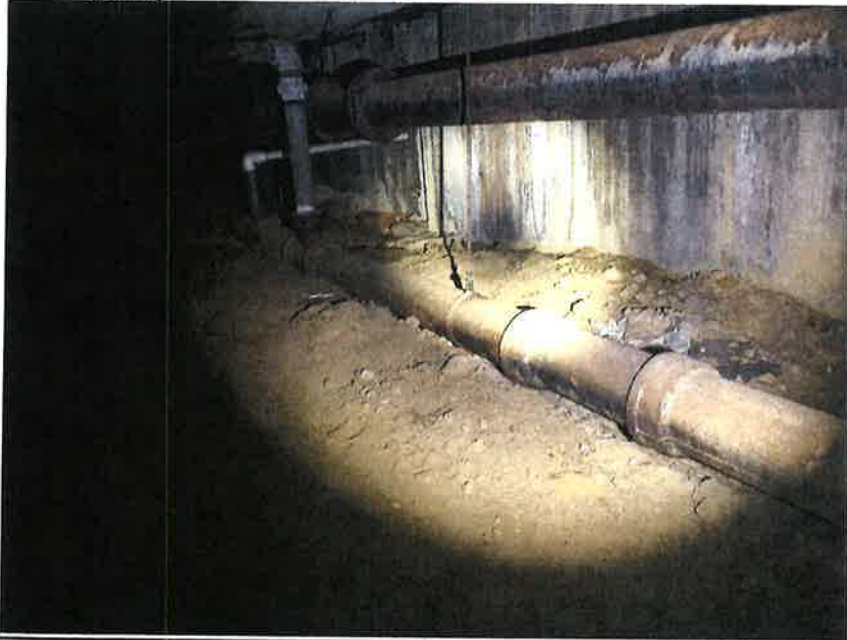
General: The overall appearance is poor. The concrete decking has been white washed or painted in the past with finish wearing or oxidizing off. The pool decks are structurally in good condition and are a structural slab for the filter area and the roof of a tunnel and pipe chase that extends around the perimeter of the pool making pool piping accessible.

Deck Drains: The decks have some areas that are not draining properly and letting water stand. With shifting of the pool there is some effect on deck elevations which could affect drainage in areas.

Perimeter decking

Coping and curbs have been painted in the past. Curb paint is peeling and spalling and needs to be sandblasted, concrete repaired and rubbed out and new paint or coating applied.

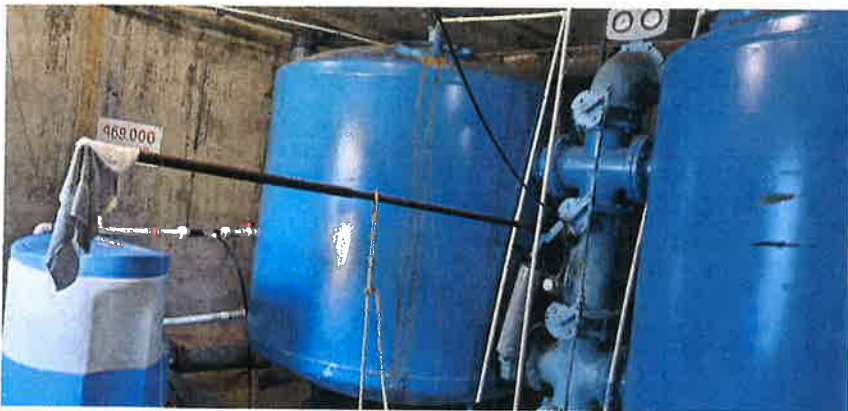
Filters

General: The pool has dual 78 inch steel filters located in the filter room below deep end concrete deck (Our pool calculation show slightly more water volume in the pool than you have listed). This shows the filter system slightly undersized. Because of the age and volume you have shown we would not address at this time.

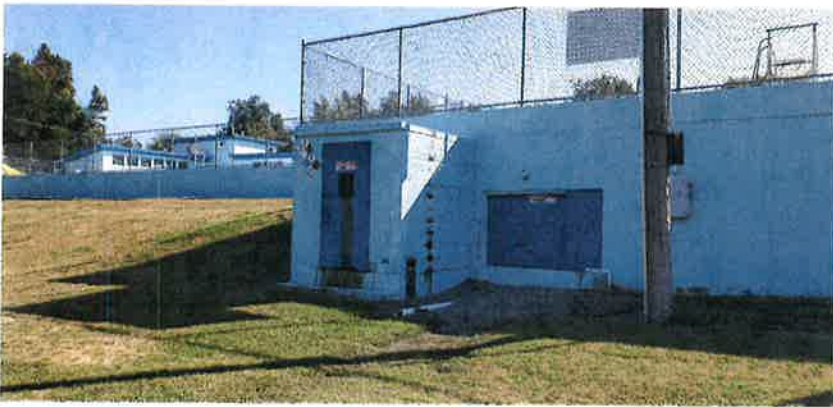
The structure has shifted showing cracks in the block walls. The acid has corroded metal items such as the door and frame.

The exhaust fan is not operating. This item should be replaced and be in operational condition.

Chemical storage building.

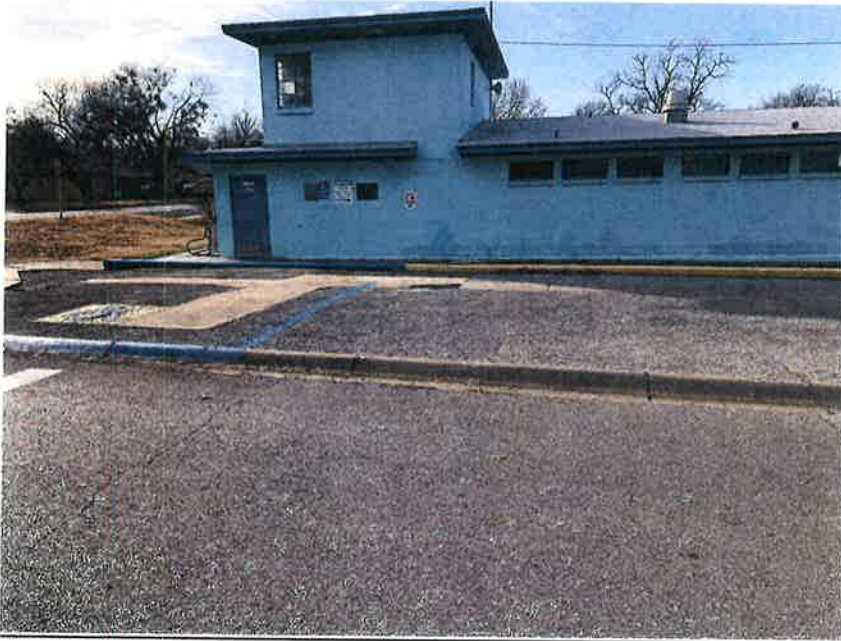
Parking, entrances, counters are not in A.D.A. compliance

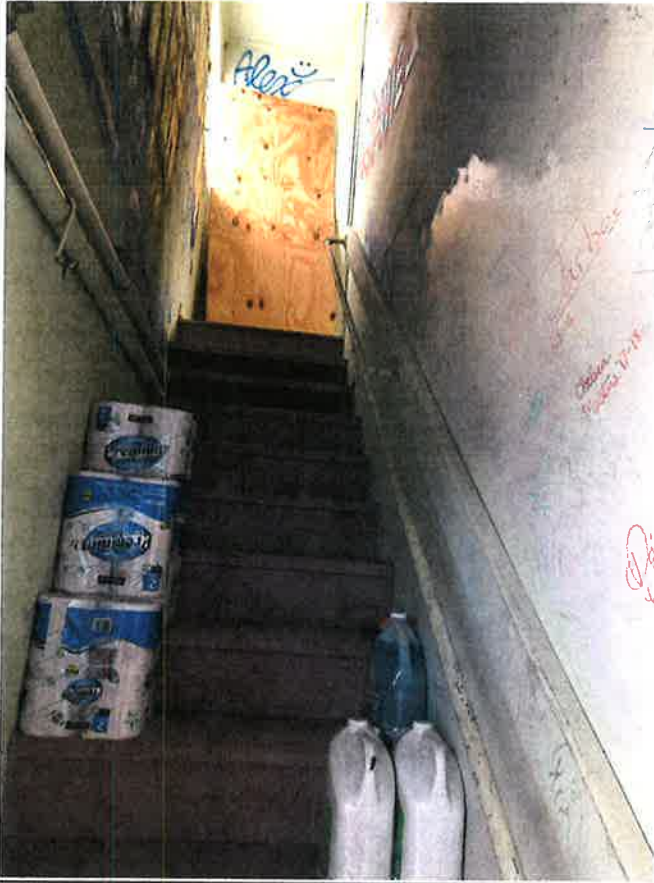
Abandoned upstairs in bathhouse.

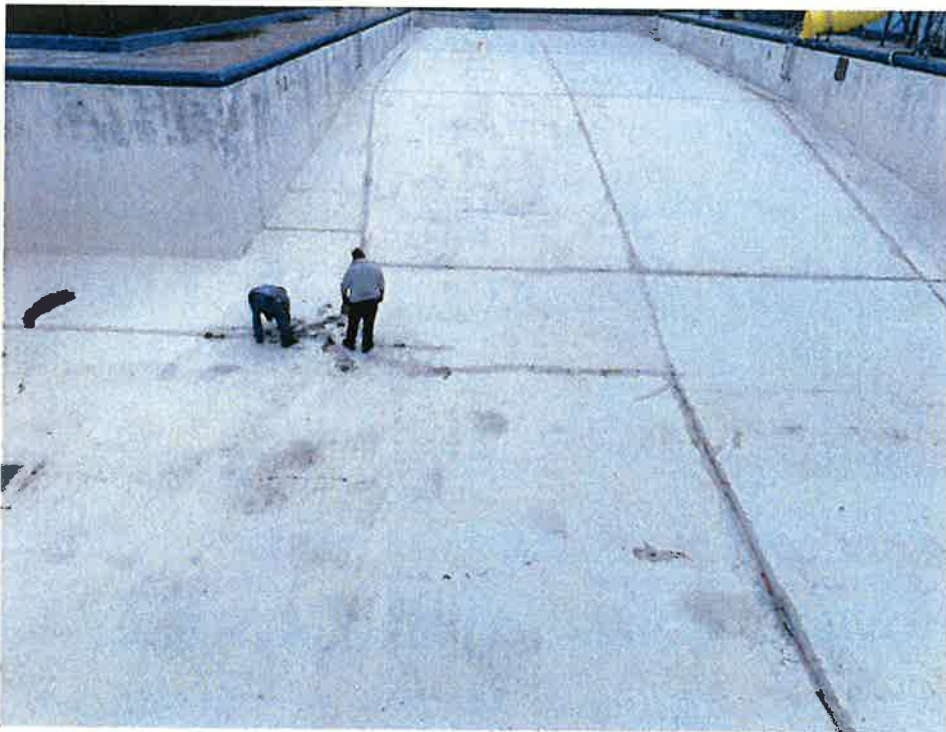
*Figure 2 TEAM EXPLORING SPAULING JOINT*

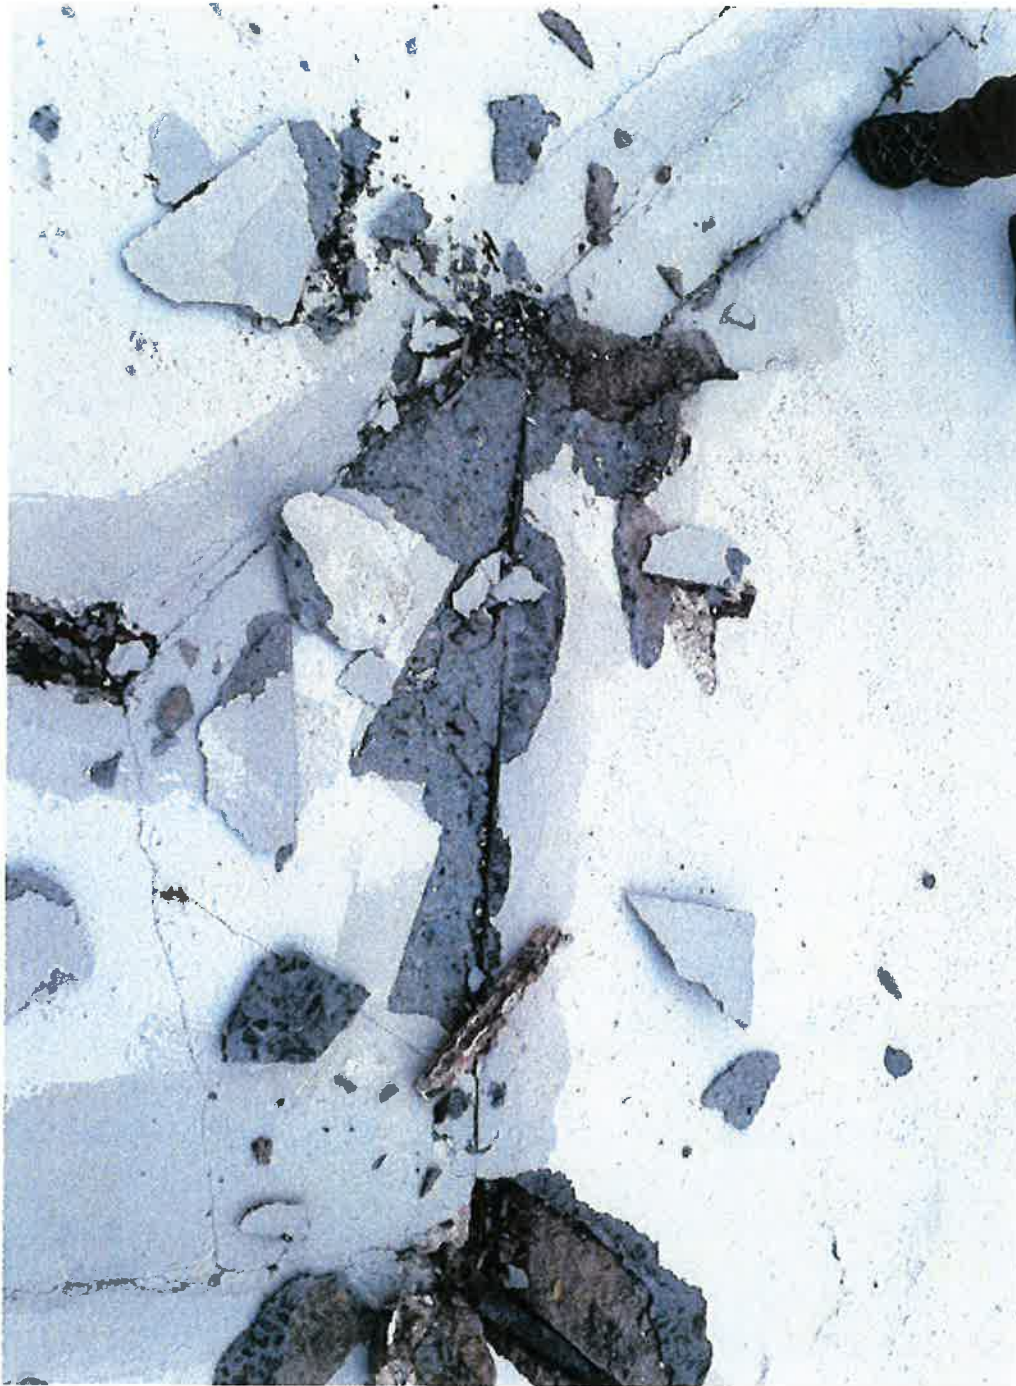
*Figure 3 CLOSE UP OF WEATHERED JOINT*

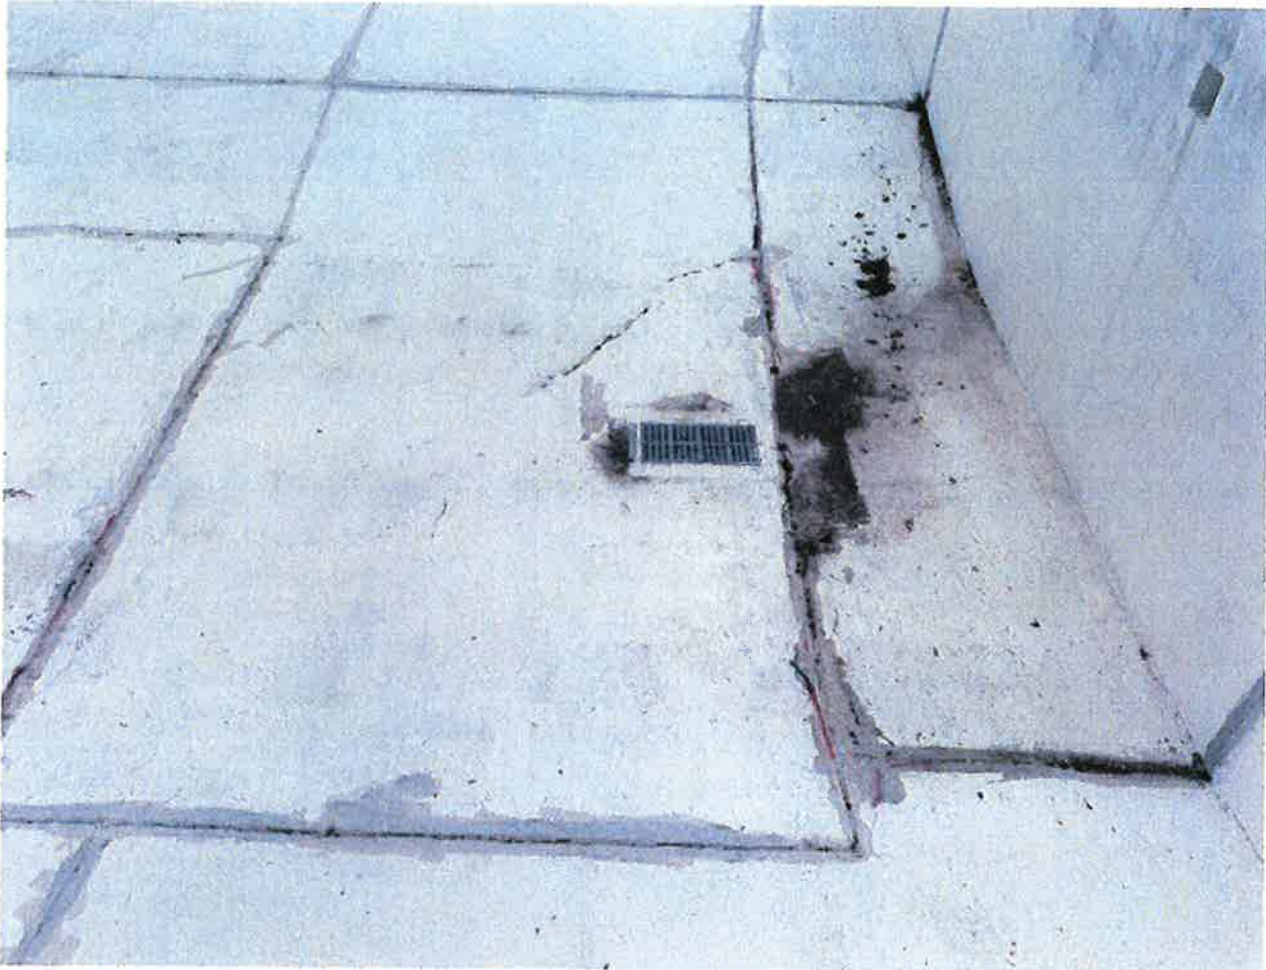
*Figure 4 CONCRETE STRUCTURAL CRACK*

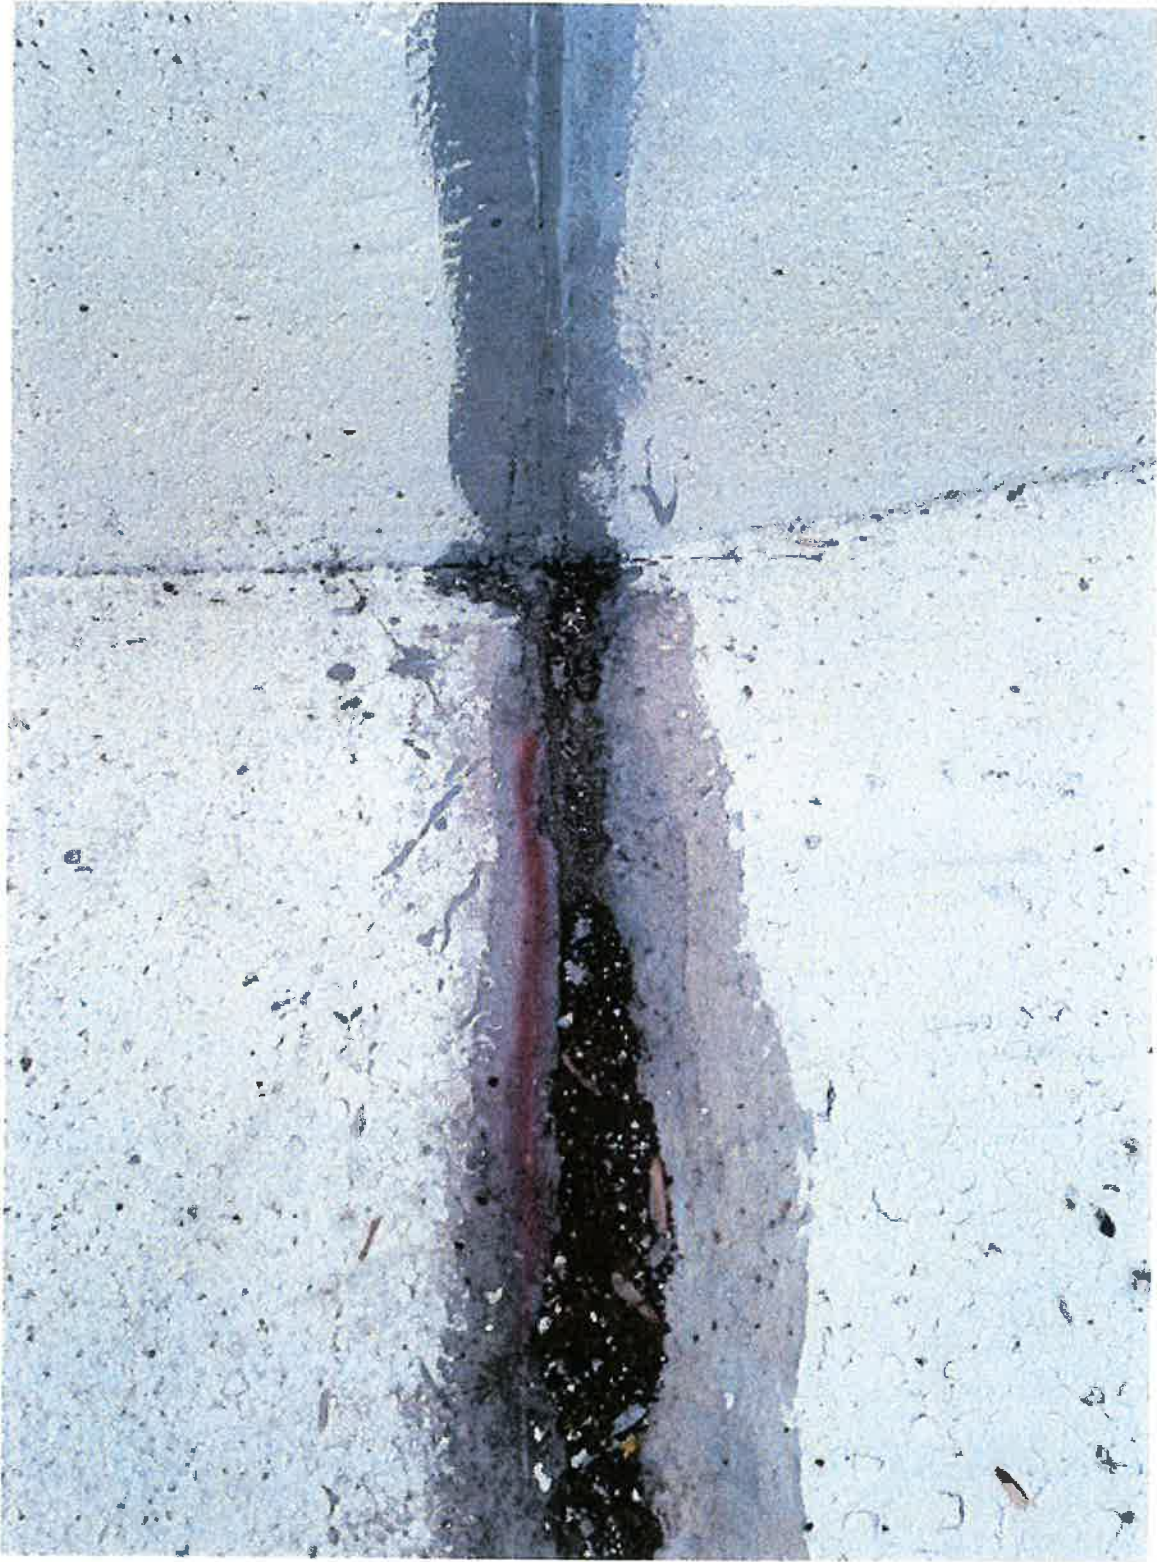
2. **Concrete Floor Repair:** - The visual inspection of the concrete bottom indicated all const. joints throughout the pool have visible signs of leakage. With the pool empty, the joints are leaking water into the pool, during daily operation these same joints will leak water out of the pool to the lowest levels where historical wet grounds and constant pump station operation of the French drain system supports the active leakage. The caulk within the joints has become brittle and cracked throughout the pool. Some joints have experienced freeze and spauling which is an annual occurrence, but due to the extreme cold weather of the winter of 2020-21 joint degradation has increased. The ultimate repair shall include saw cutting, removal of all joint material, clean up, and replace all joints with marine grade polysulfide joint system to sound concrete. Concrete spauling along the joints shall be brought back to grade with water proofing patching compound which is especially composed to adhere to existing concrete and create a water proof connection.

Figure 5 LEAKING BRITTLE CONST. JOINT

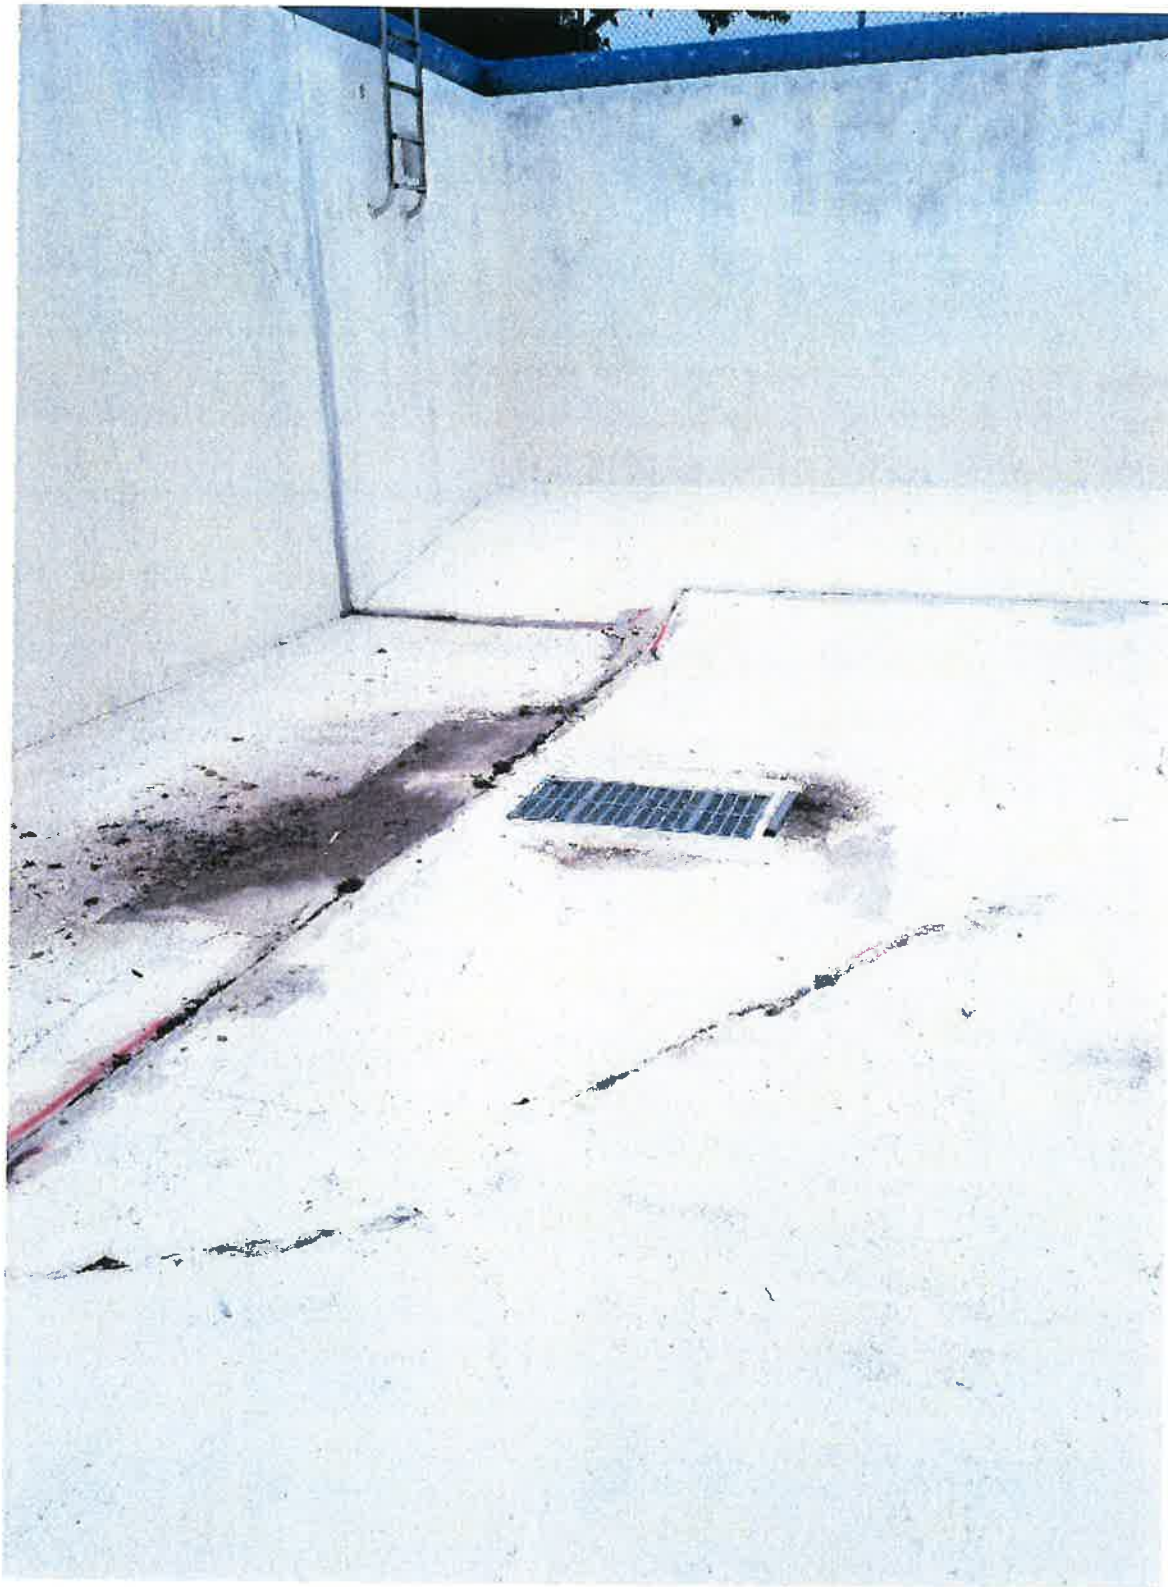
*Figure 6 DEEP END POOL WATER LEAKAGE*

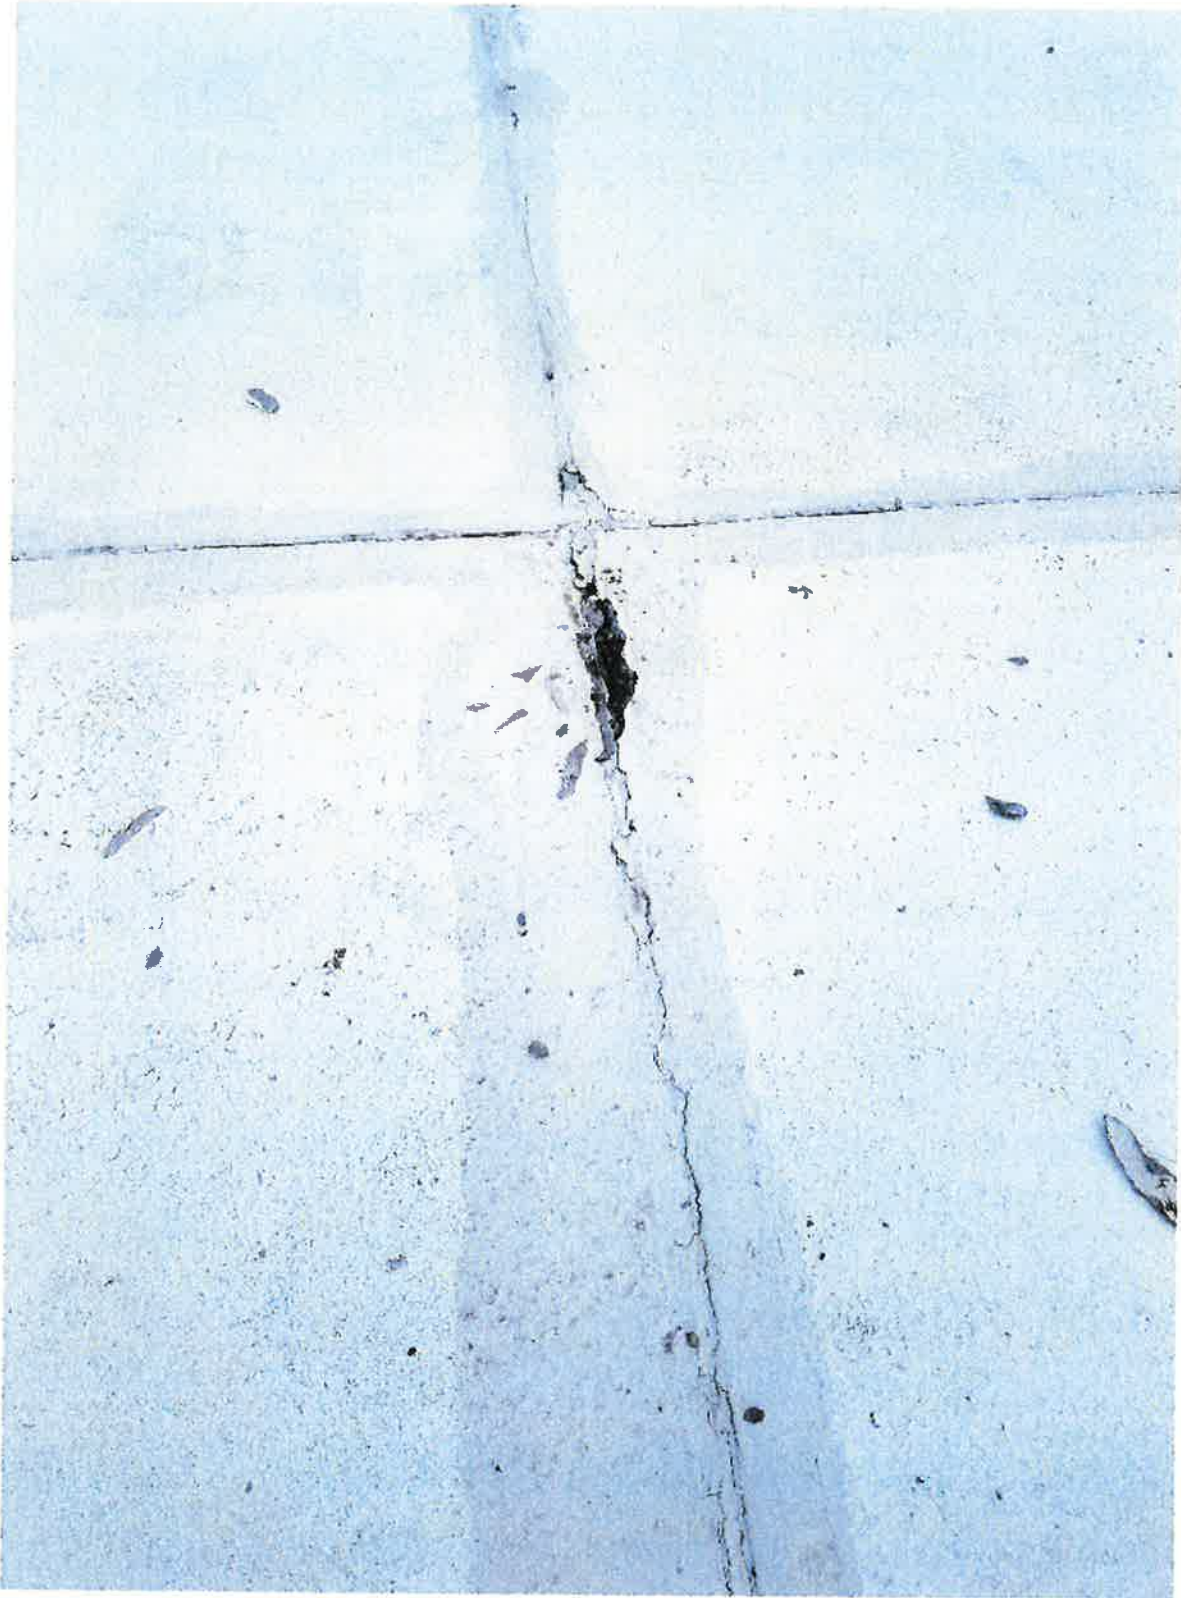
*Figure 7 JOINT WITH DETACHED CONCRETE SEAM*

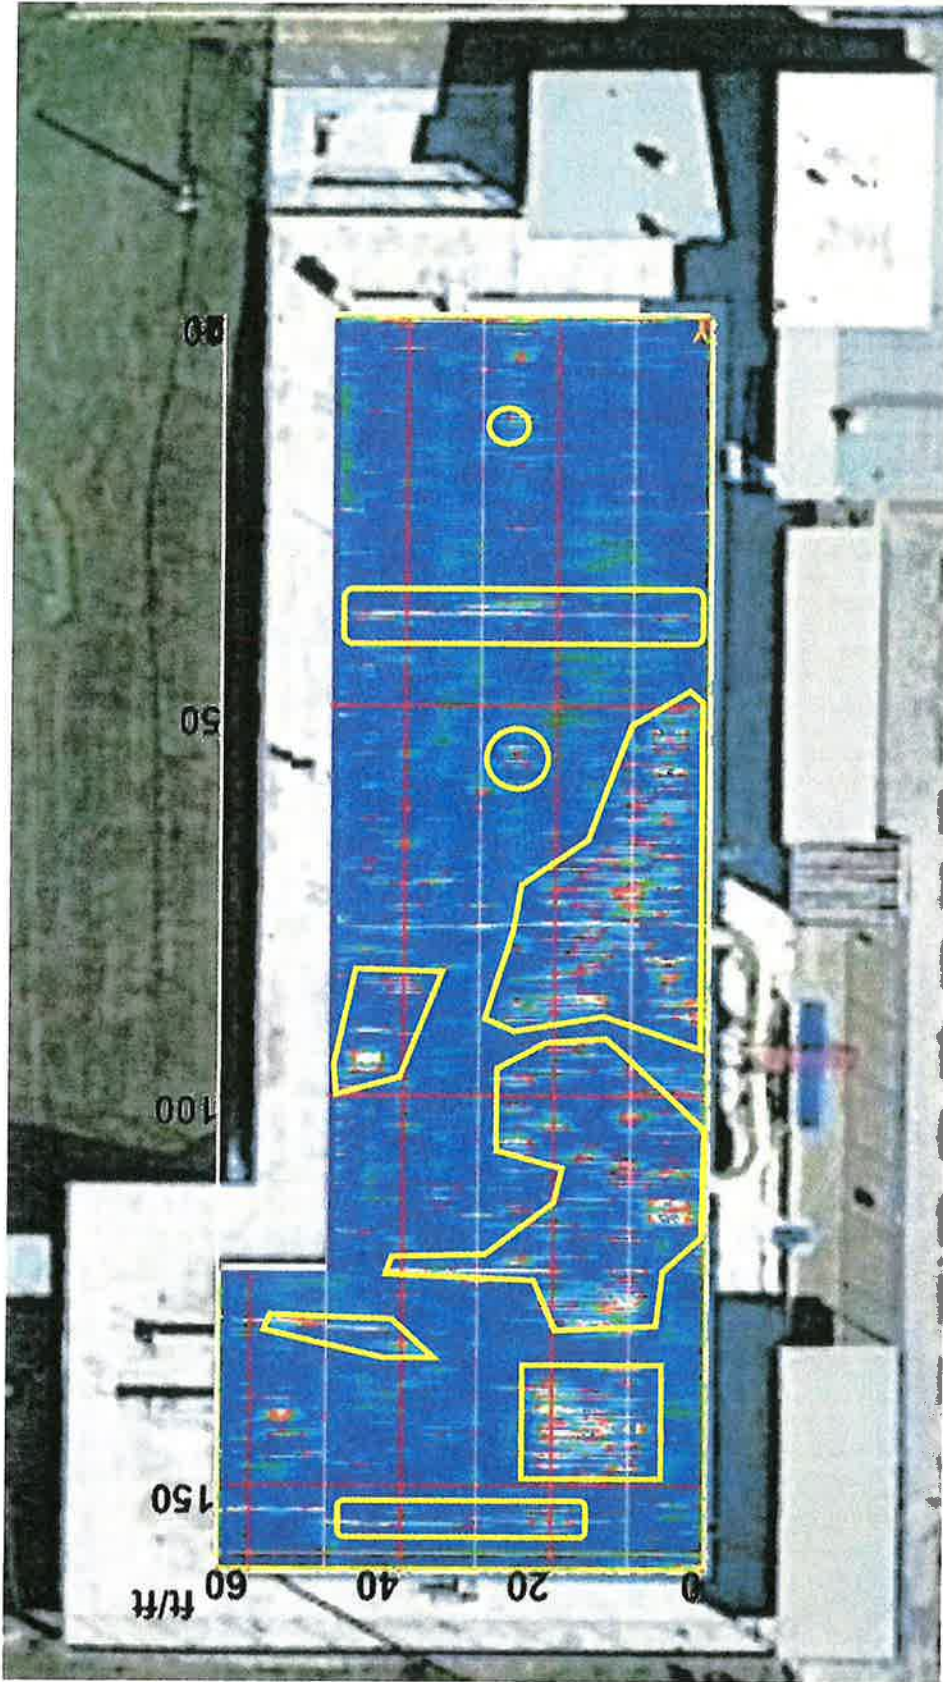
GPR Results Diagram  
 Public Swimming Pool  
 Pryor, Oklahoma

Areas circled in yellow are potential voids under the slab. The GPR cannot quantitatively measure the vertical airspace in a void but based on prior experience we estimate the voids likely range from 1/2 inch to 3 inches of vertical expression.
