**MINUTES
PARK BOARD
REGULAR MEETING
MONDAY, APRIL 26TH, 2021
5:30 P.M.**

TECHNICAL MEMORANDUM
WHITAKER PARK SWIMMING POOL
LIMITED STUDY
Pryor, Oklahoma

SWIMMING POOL REPAIRS

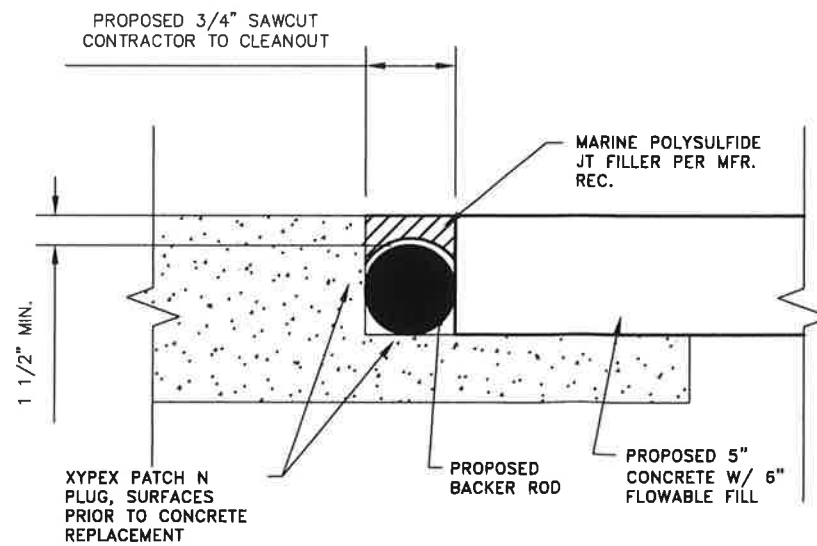
JT DETAIL
SCALE: NTS

TYPE III JT REPAIR
SCALE: NTS

2. Concrete Floor Repair: - The visual inspection of the concrete bottom indicated all const. joints throughout the pool have visible signs of leakage. With the pool empty, the joints are leaking water into the pool, during daily operation these same joints will leak water out of the pool to the lowest levels where historical wet grounds and constant pump station operation of the French drain system supports the active leakage. The caulk within the joints has become brittle and cracked throughout the pool. Some joints have experienced freeze and spauling which is an annual occurrence, but due to the extreme cold weather of the winter of 2020-21 joint degradation has increased. The ultimate repair shall include saw cutting, removal of all joint material, clean up, and replace all joints with marine grade polysulfide joint system to sound concrete. Concrete spauling along the joints shall be brought back to grade with water proofing patching compound which is especially composed to adhere to existing concrete and create a water proof connection.

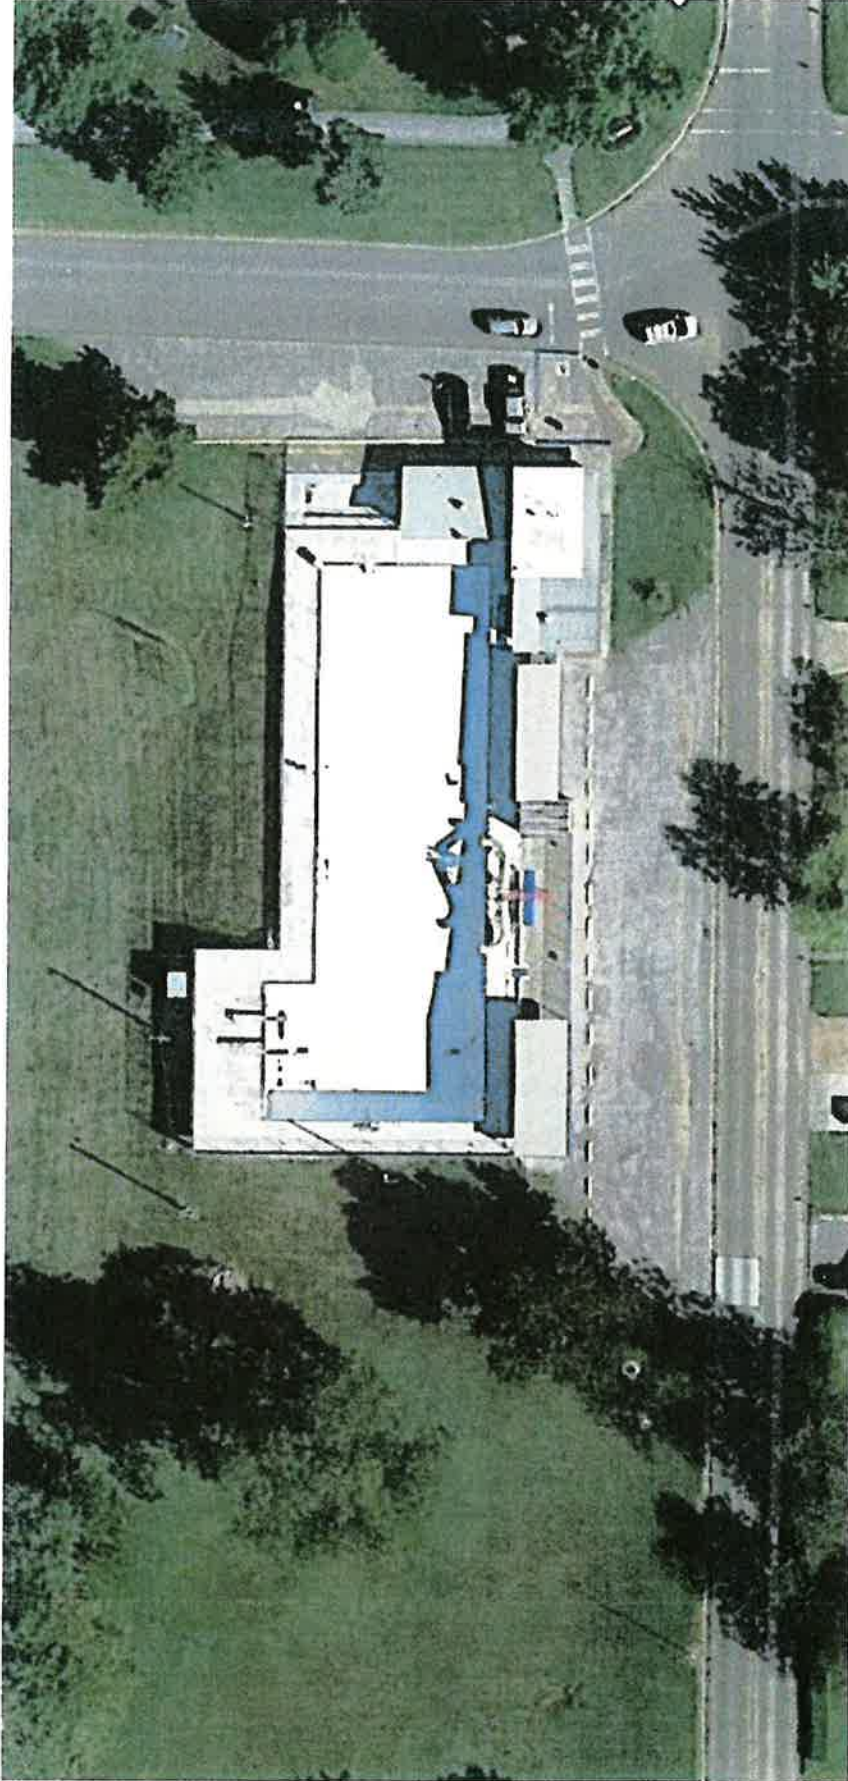
The area of concern included the bottom slab of the pool measuring approximately 160 feet by 65 foot wide.

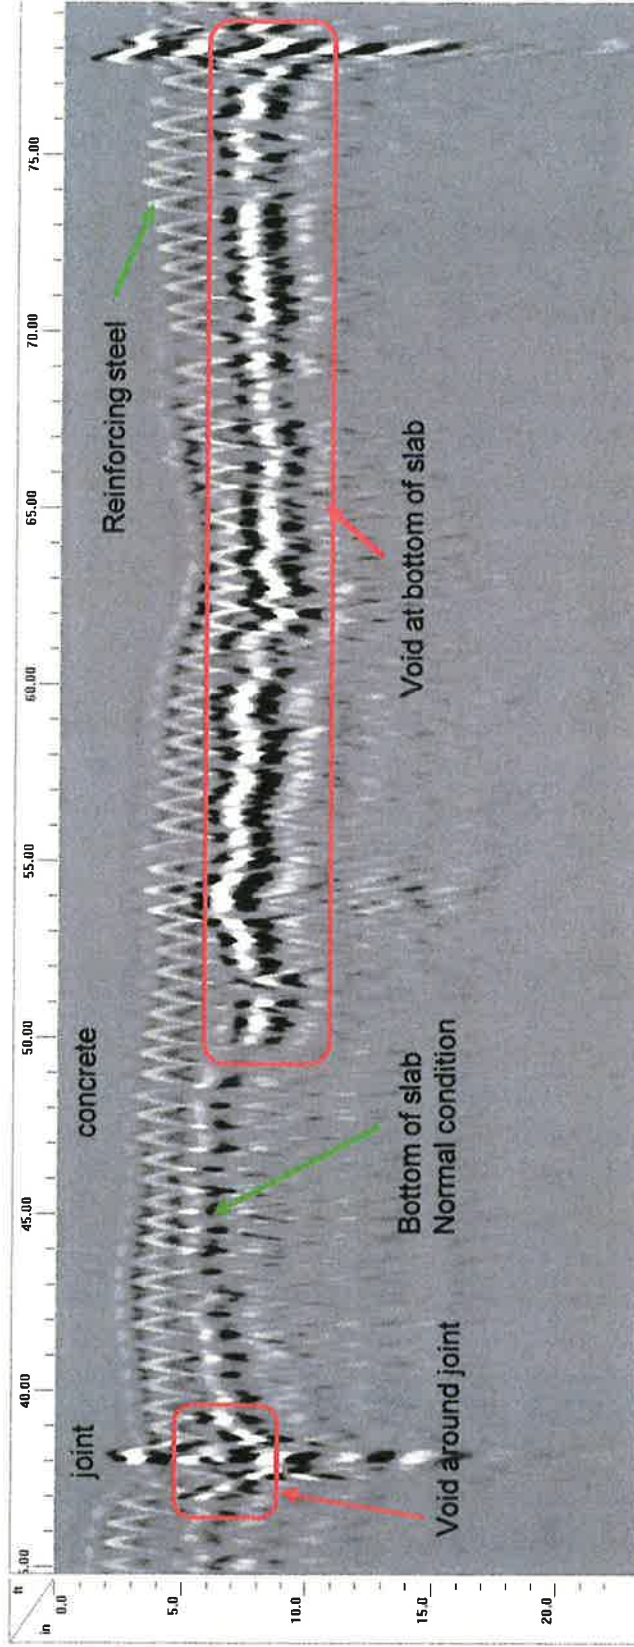
GPR Results Diagram	Exhibit
Public Swimming Pool	2
Pryor, Oklahoma

The GPR indicated concrete thickness of 10 to 12 inches with reinforcement on 8 inches on center around the perimeter and 5 to 6 inches of concrete thickness with 6 inch on center spacing on the remainder of the slab. The GPR data indicated data signatures consistent with voids along several of the joints and in larger areas primarily on the south and southwest portion of the pool. The GPR cannot quantitatively measure the vertical airspace in a void but based on prior experience we estimate the voids likely range from 1/2 inch to 3 inches of vertical expression. No significant subsurface soil or fill anomalies were noted in the GPR data to a depth of 20 inches below surface.
