**INSPECTION REPORT  
FOR THE EXISTING  
OUTDOOR MUNICIPAL  
SWIMMING POOL  
IN  
Pryor, Oklahoma**

**November, 2019**

**PADDOCK ENTERPRISES, INC.  
4201 N. MERIDIAN - P.O. BOX 12693  
OKLAHOMA CITY, OKLAHOMA 73157**

TECHNICAL MEMORANDUM  
WHITAKER PARK SWIMMING POOL  
LIMITED STUDY  
Pryor, Oklahoma

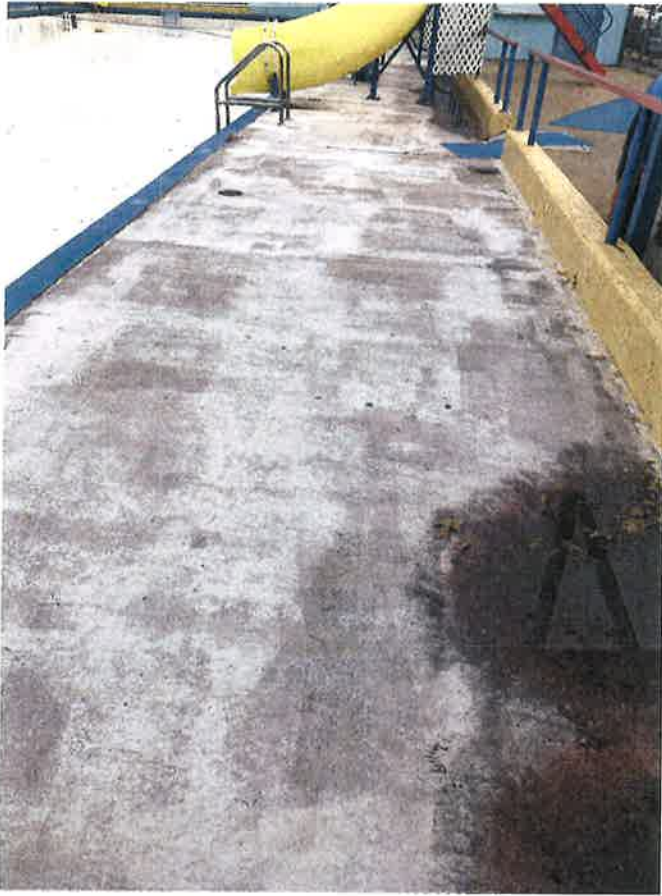
Perimeter decking

Coping and curbs have been painted in the past. Curb paint is peeling and spalling and needs to be sandblasted, concrete repaired and rubbed out and new paint or coating applied.

Deck Drains: The decks have some areas that are not draining properly and letting water stand. With shifting of the pool there is some effect on deck elevations which could affect drainage in areas.

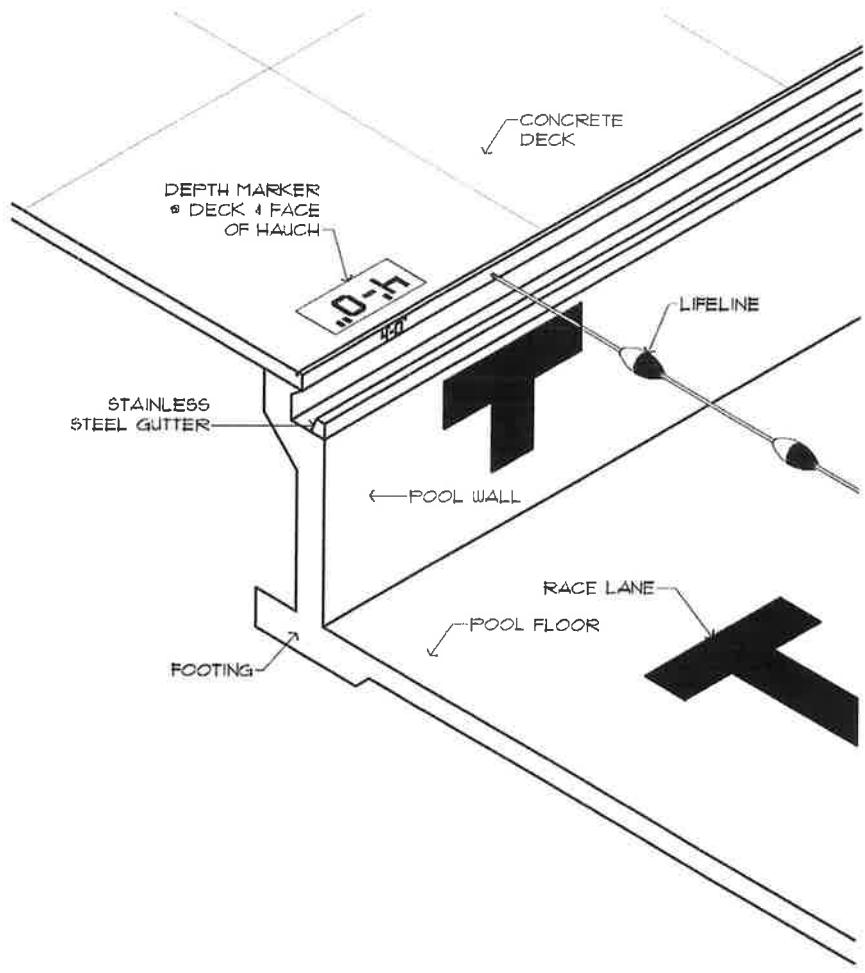
ISOMETRIC  
 WALL DETAIL

**Isometric showing stainless steel recirculation system at the top of the pool wall this incorporates inlet system and pool overflow.**

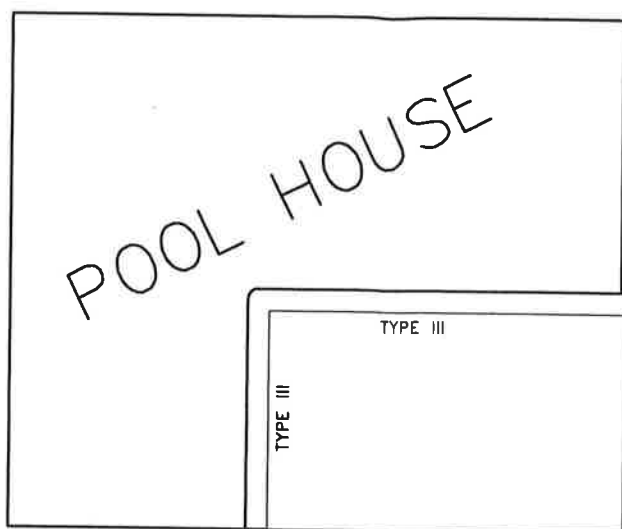
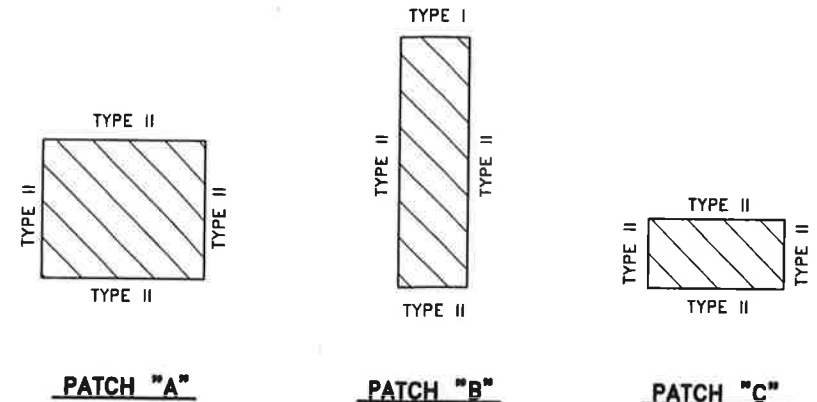
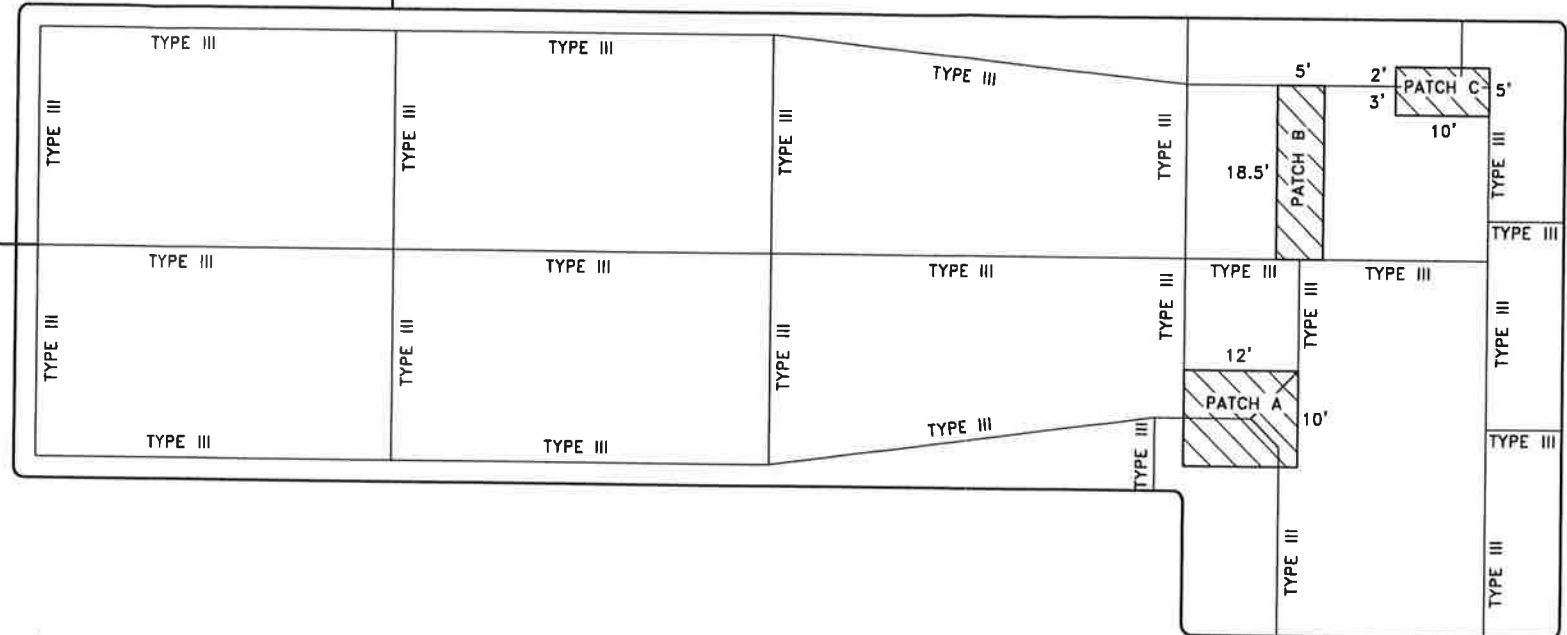
**JOINT AND CONCRETE REPAIR LAYOUT**  
SCALE: 1"=10'

In addition, specific sections of the concrete floor have experienced more extensive damage to just seal the joints. We have isolated three sections of concrete slab that must be saw cut removed and replaced including sub grade use of flowable fill and drilled dowels to surrounding concrete flooring. The three sections occur primarily in the deep end of the pool where subterranean water migration has collected and during the very cold winter months have caused extensive movement due to freeze expansion. Water proofing the pool bottom mitigating subterranean water movement or improved collection of that water is needed to minimize such slab damage in the future.

LENGTH OF JOINTS:	740 L.F.
AREA OF REPAIRS:	
AREA A	120 SF
AREA B	90.5 SF
AREA C	50 SF
TOTAL AREA	260.5 SF

**In Summary-** Concrete repair of the joints and isolated concrete slab repairs are required. A change in winter operation is also suggested. Leaving at least 2 feet of water in the pool at the shallow end which will provide over 6 feet of water in the deep end of the pool will reduce joint deuteriation thus extending the life of the caulked joints. Water in the pool during winter months requires special preparation. Expansion floating pillows shall be anchored to the partially filled pool to allow expansion of the ice that will form on the water. These pillows rise and fall with ice presence to avoid damage or undue forces on pool walls. In addition, the partially filled pool water should be periodically treated with anti-freeze material specifically formulated for such applications. All valves and piping should be drained and water should not be filled to such a height as to enter the overflow weirs and return nozzles. The change in pool winterization procedure requires preparation, capital expenditure of funds for expansion prevention equipment, chemical and repeated visitation to replenish chemicals, adjust pillow blocks and break up ice.

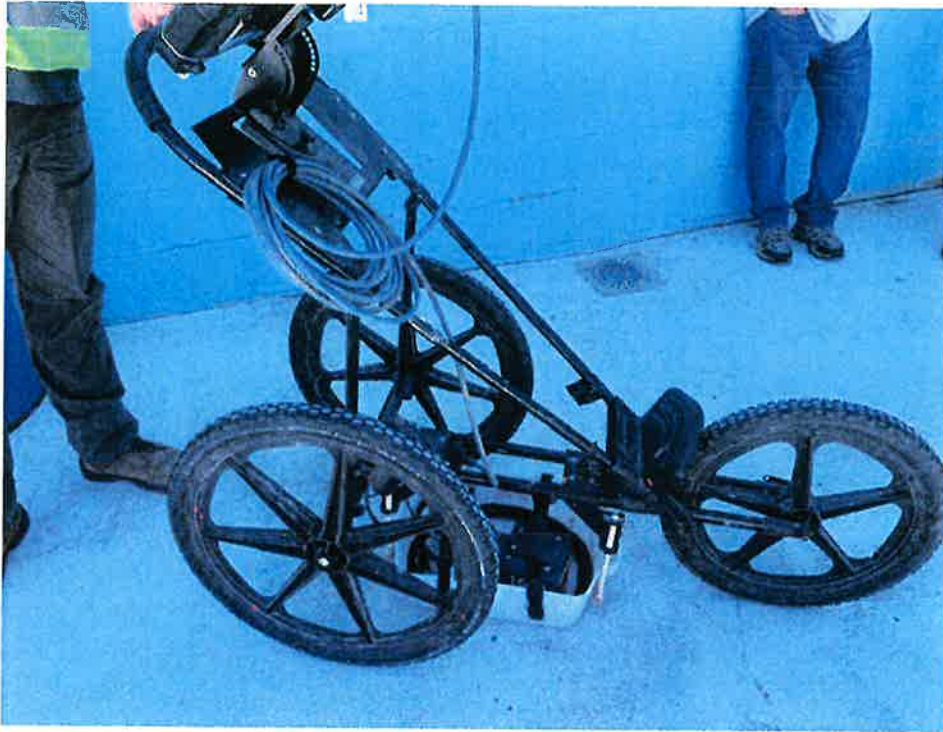
*Figure 2 TEAM EXPLORING SPAULING JOINT*

2. **Concrete Floor Repair:** - The visual inspection of the concrete bottom indicated all const. joints throughout the pool have visible signs of leakage. With the pool empty, the joints are leaking water into the pool, during daily operation these same joints will leak water out of the pool to the lowest levels where historical wet grounds and constant pump station operation of the French drain system supports the active leakage. The caulk within the joints has become brittle and cracked throughout the pool. Some joints have experienced freeze and spauling which is an annual occurrence, but due to the extreme cold weather of the winter of 2020-21 joint degradation has increased. The ultimate repair shall include saw cutting, removal of all joint material, clean up, and replace all joints with marine grade polysulfide joint system to sound concrete. Concrete spauling along the joints shall be brought back to grade with water proofing patching compound which is especially composed to adhere to existing concrete and create a water proof connection.

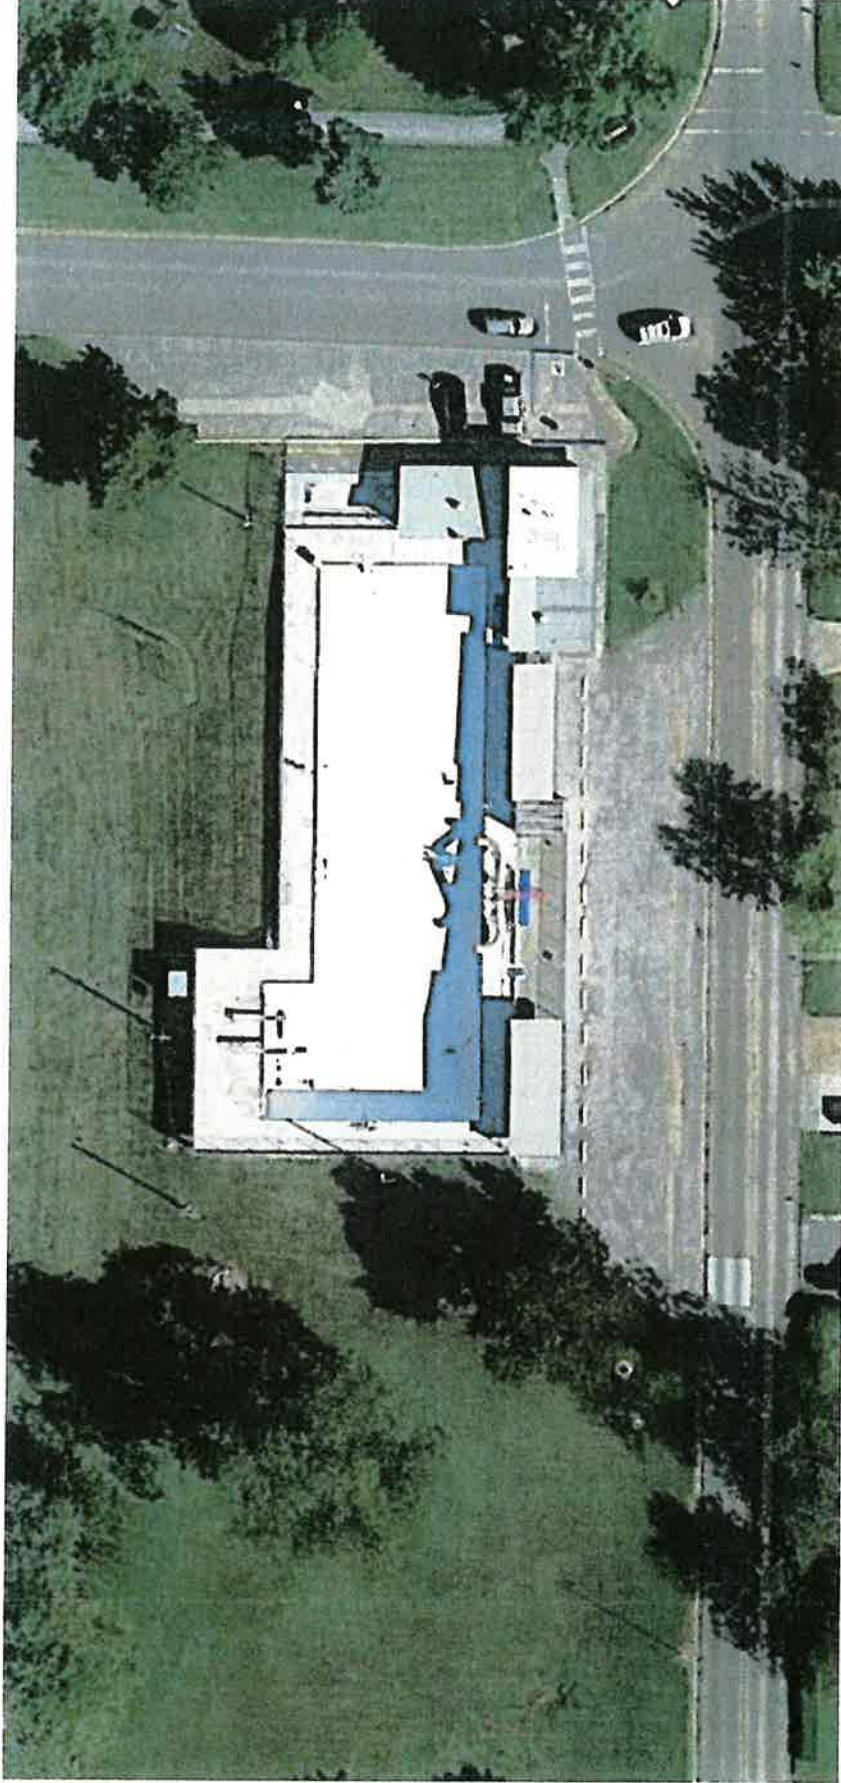
GPR Results Diagram  
 Public Swimming Pool  
 Pryor, Oklahoma

The area of concern included the bottom slab of the pool measuring approximately 160 feet by 65 foot wide.

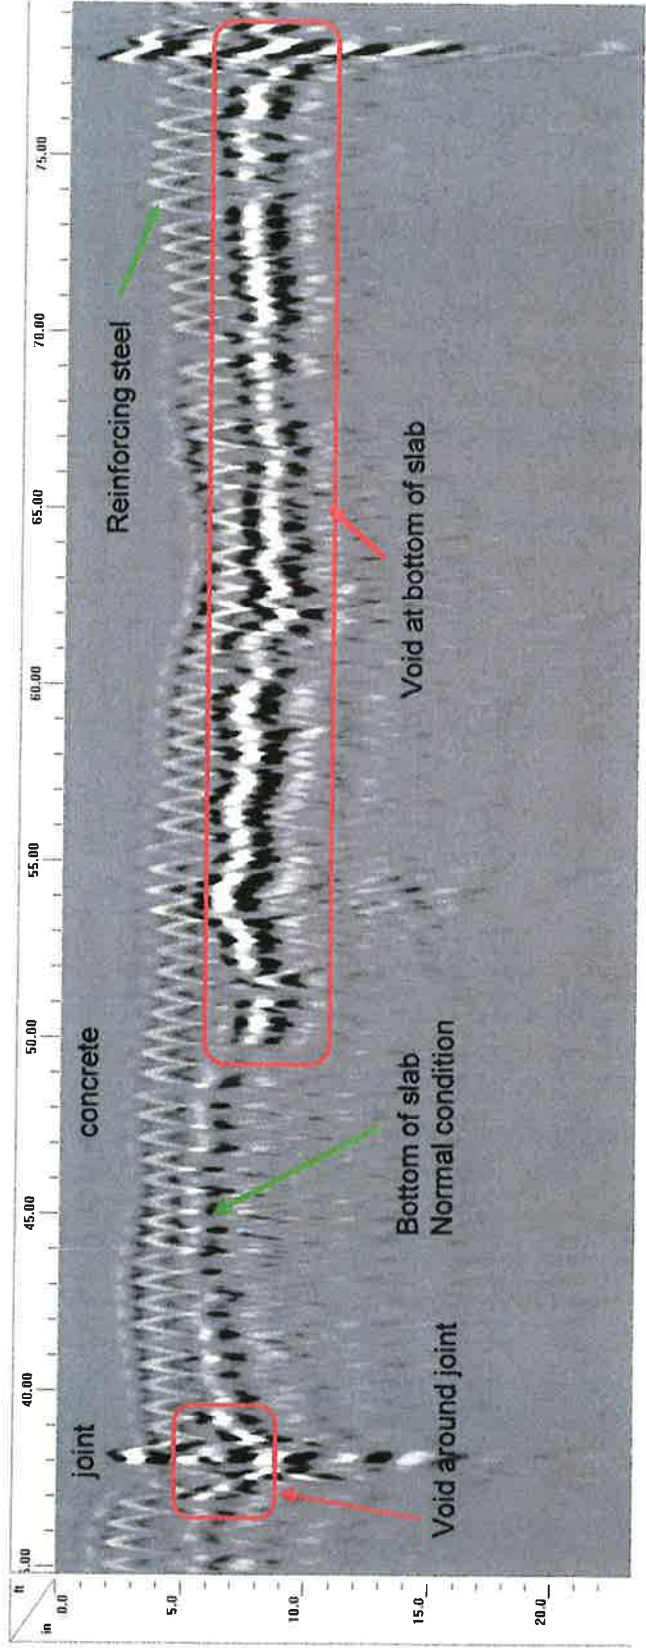
In summary, voids were found at numerous locations, but the depth of these voids were only a few inches which does not indicate an immediate need to expose and fill those voids. Therefore, all work shall be associated with observed issues found during the inspections and based on sound engineering practices.

The GPR indicated concrete thickness of 10 to 12 inches with reinforcement on center around the perimeter and 5 to 6 inches of concrete thickness with 6 inch on center spacing on the remainder of the slab. The GPR data indicated data signatures consistent with voids along several of the joints and in larger areas primarily on the south and southwest portion of the pool. The GPR cannot quantitatively measure the vertical airspace in a void but based on prior experience we estimate the voids likely range from 1/2 inch to 3 inches of vertical expression. No significant subsurface soil or fill anomalies were noted in the GPR data to a depth of 20 inches below surface.
